CRAM ASSESSMENT OF THE WATSONVILLE SLOUGH FARMS

**SUBMITTED TO THE LAND TRUST OF SANTA CRUZ COUNTY BY
THE CENTRAL COAST WETLANDS GROUP**

DECEMBER, 2013

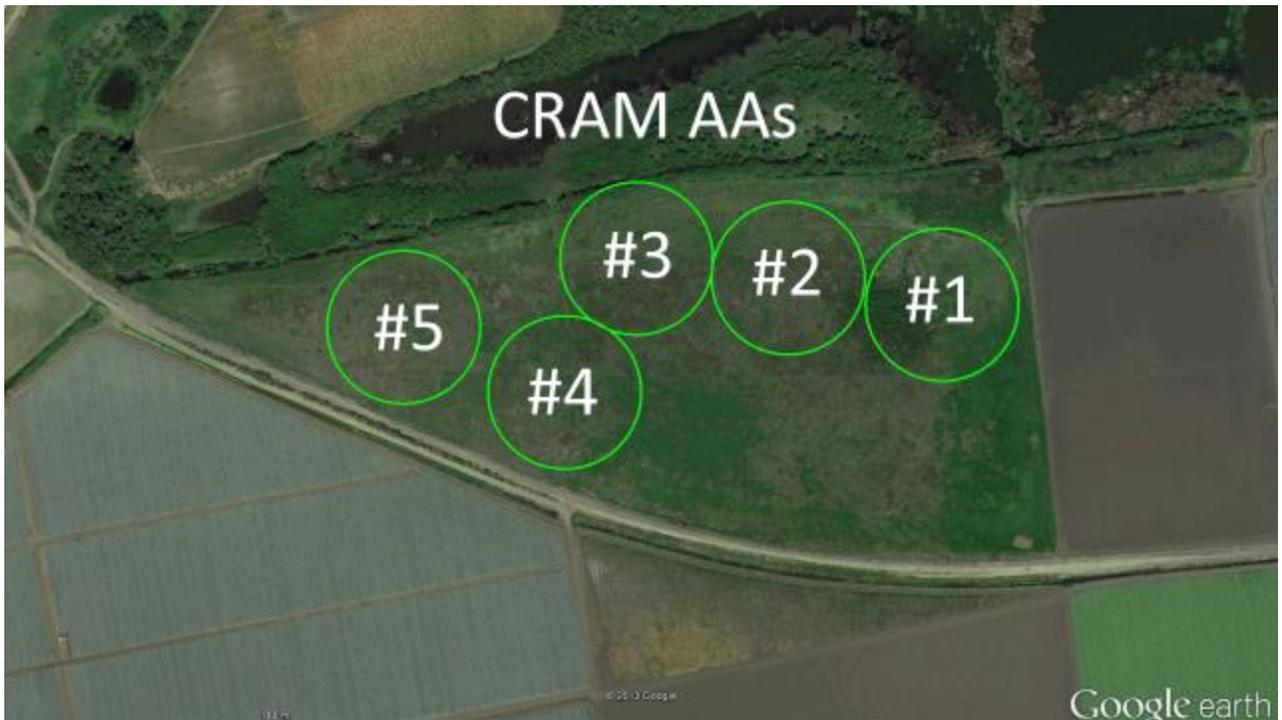
At the Bryant-Habert parcel the AAs were established in areas where the grading plan shows ponds to be excavated. The area to be graded was leveled for agriculture in the past and has very little relief throughout the parcel although it slopes gently to the north. However, the vegetation is relatively homogenous with a mix of willow scrub and wet meadow habitats. Therefore, the standard 1 hectare circular AA was used and AAs were placed at approximately the areas where the depressions will be excavated. There are four deeper ponds planned for the site, and these four areas were assessed as well as an additional circular AA in an area of mixed willow scrub and wet meadow (Figure 1). The AAs were numbered for tracking purposes.

FIGURE 1. ONE HECTARE CIRCULAR AAS AT THE BRYANT-HABERT PARCEL (#1-5)

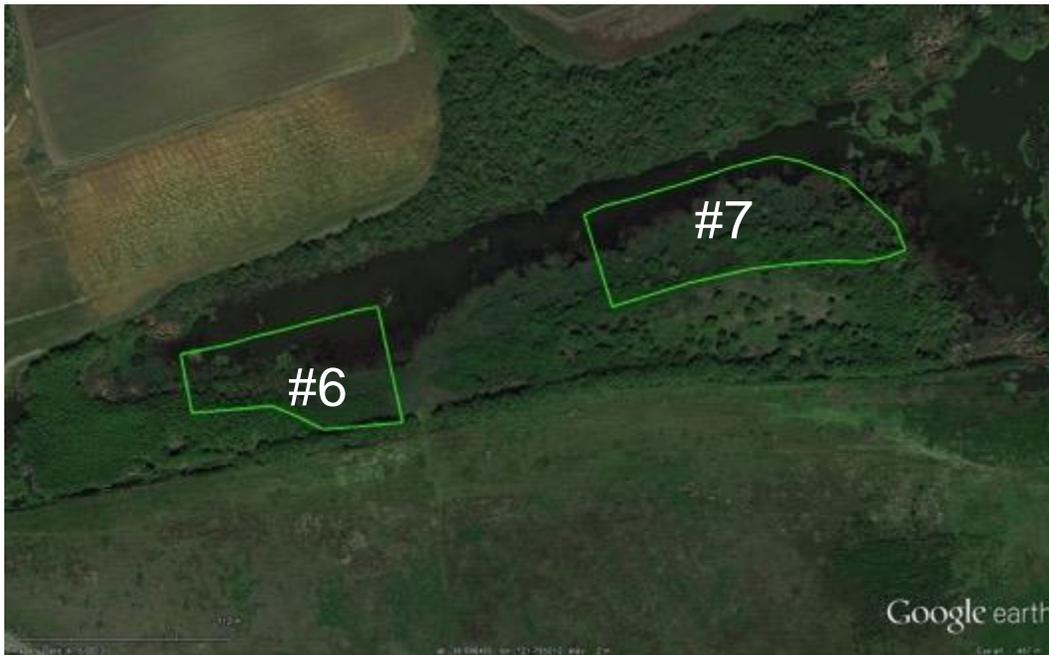
In addition to the pre-restoration assessments at Bryant-Habert, two assessments were performed in the main Watsonville Slough to assess its current condition and to give context to the pre-restoration assessments (Figure 2). These AAs were placed to encompass the gradient from the lowest elevation of the marsh up through the marsh plain and into the willow scrub. The first row of willows was included in the AA.

FIGURE 2. CRAM AAS IN THE MAIN WATSONVILLE SLOUGH (#6-7)

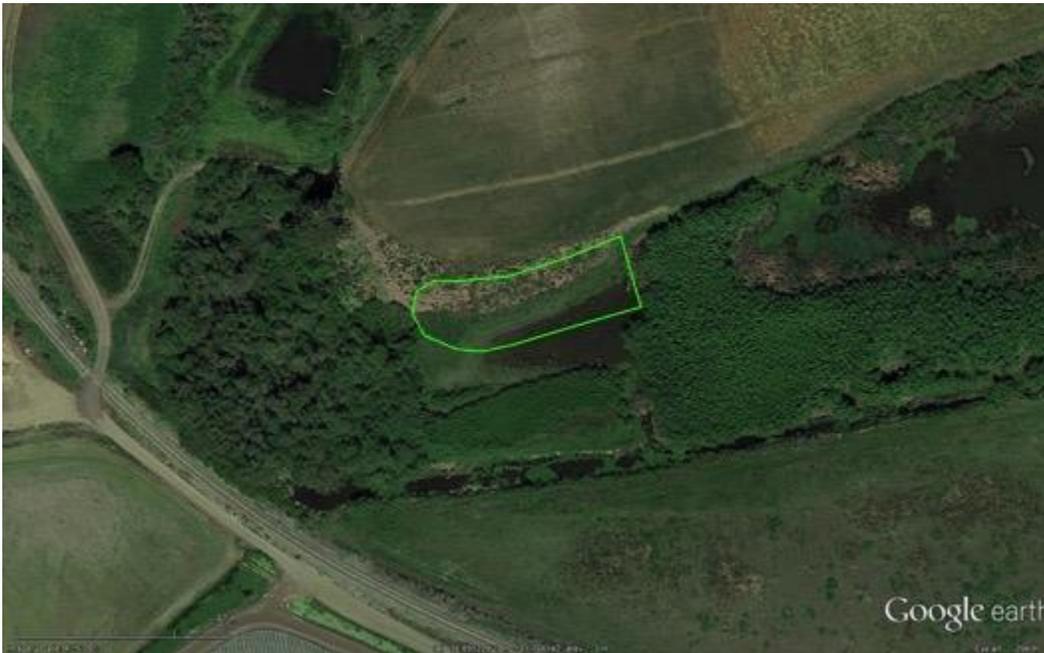
The “Thumbs” restoration project was also assessed as a demonstration of a post-restoration condition assessment (Figure 3). The AA was defined to include the wetland area that was restored using native plantings, as well as the adjacent wetland down to 10 meters into the unvegetated mudflat, which is the rule for CRAM AAs.

FIGURE 3. CRAM AA AT THE “THUMBS” RESTORATION SITE

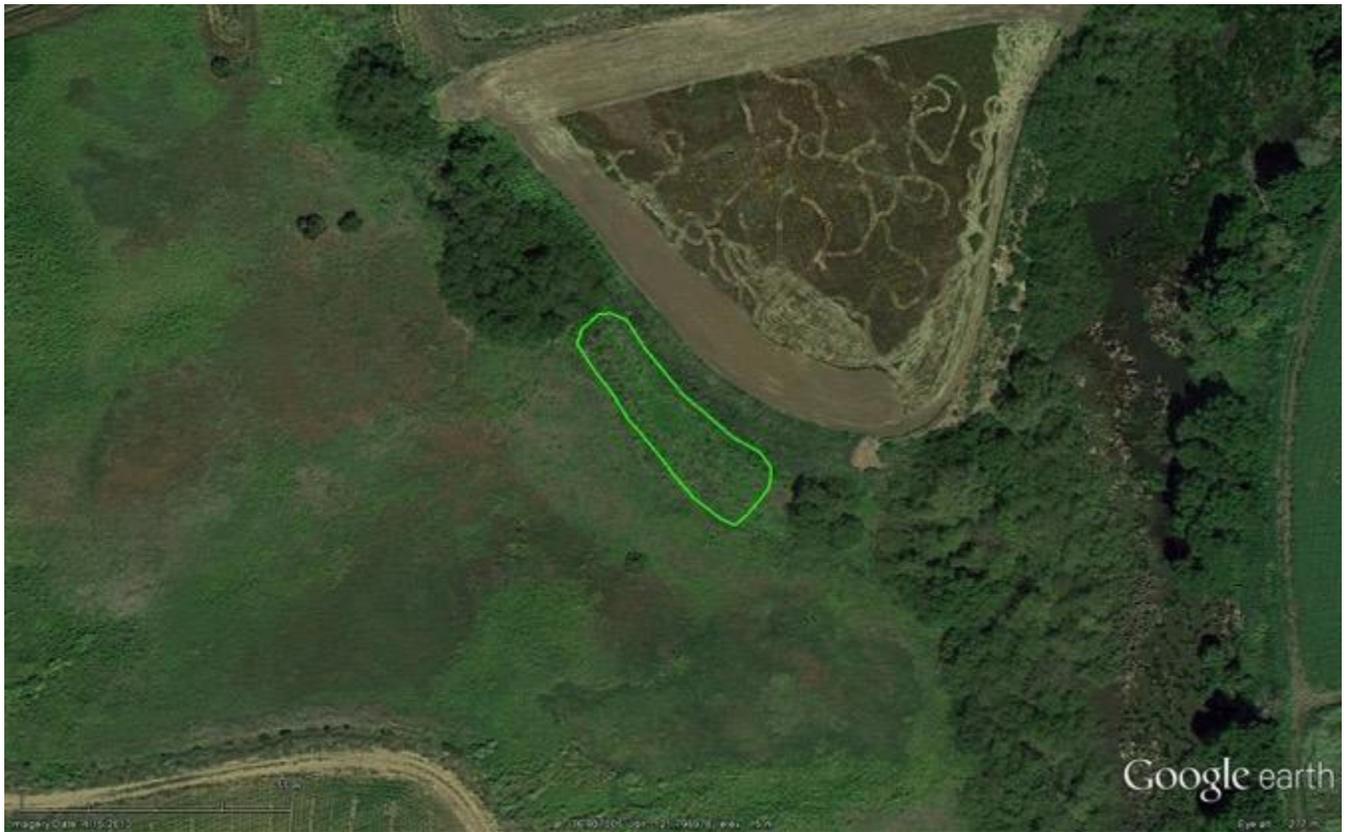
At the Upper Hanson Pond site the boundaries of the AA were defined based on the footprint of the pond to be constructed on the site. When we visited the site the location of the earthen berm was staked out and we were able to see where the maximum inundation level would be. The CRAM AA includes the wetland itself and any adjacent riparian area that has vegetation directly overhanging the wetland. At the Upper Hanson Pond site the surrounding vegetation was mowed so there wasn't any overhanging vegetation to include in the AA. Therefore the boundary was narrowly defined as the footprint of the future pond (Figure 4).

FIGURE 4. CRAM AA AT THE UPPER HANSON POND RESTORATION SITE

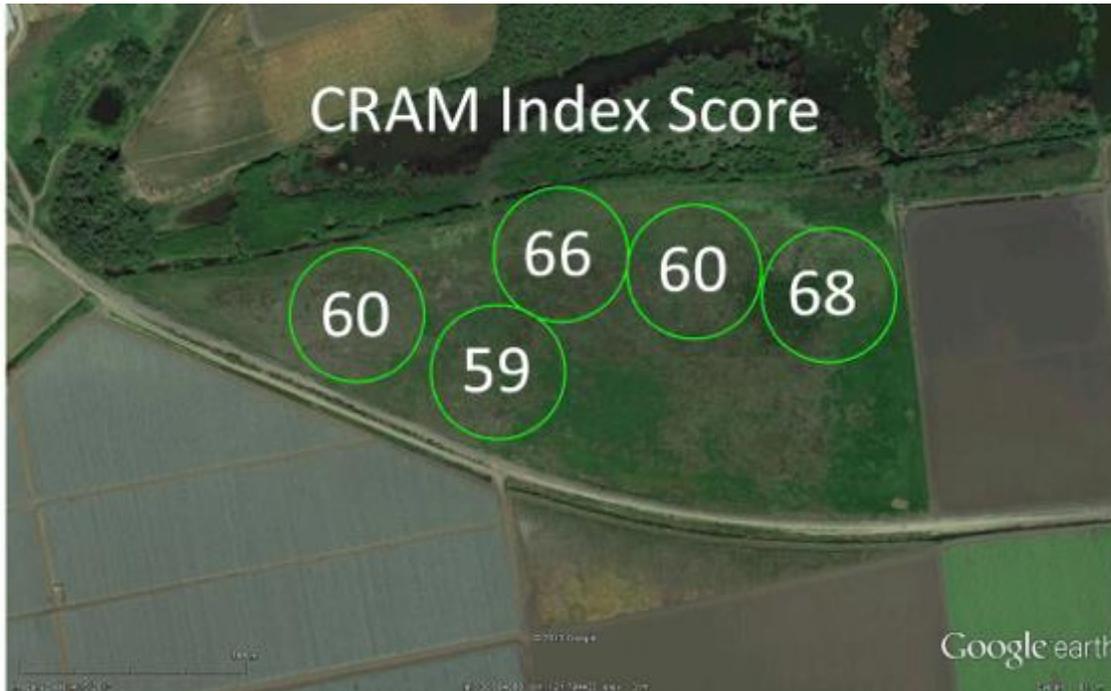
The pre-restoration assessments of the Bryant-Habert parcel show CRAM Index scores ranging from 59 to 68, with a mean of 62 (Figure 5). The highest scoring AA was located on the eastern edge of the property. This AA scored higher on the Landscape Context and Biotic Attributes due to its proximity to a wider part of the main slough and the presence of a large willow thicket, which increased the number of plant layers and dominant species.

FIGURE 5. PRE-RESTORATION CRAM INDEX SCORES

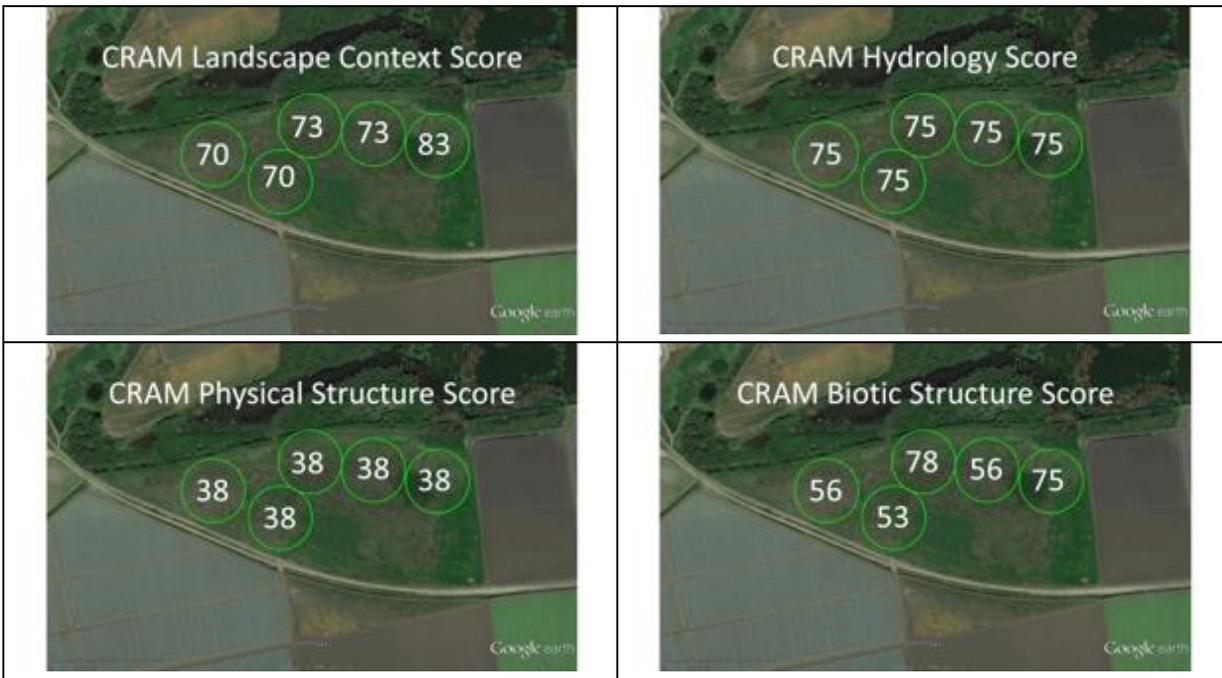
For the five pre-restoration assessments, the Landscape Context Attributed ranged from 70-83, there was no variation in the Hydrology or Physical Structure Attribute, and the Biotic Attribute ranged from 53-78 (Figure 6).

FIGURE 6. PRE-RESTORATION CRAM ATTRIBUTE SCORES

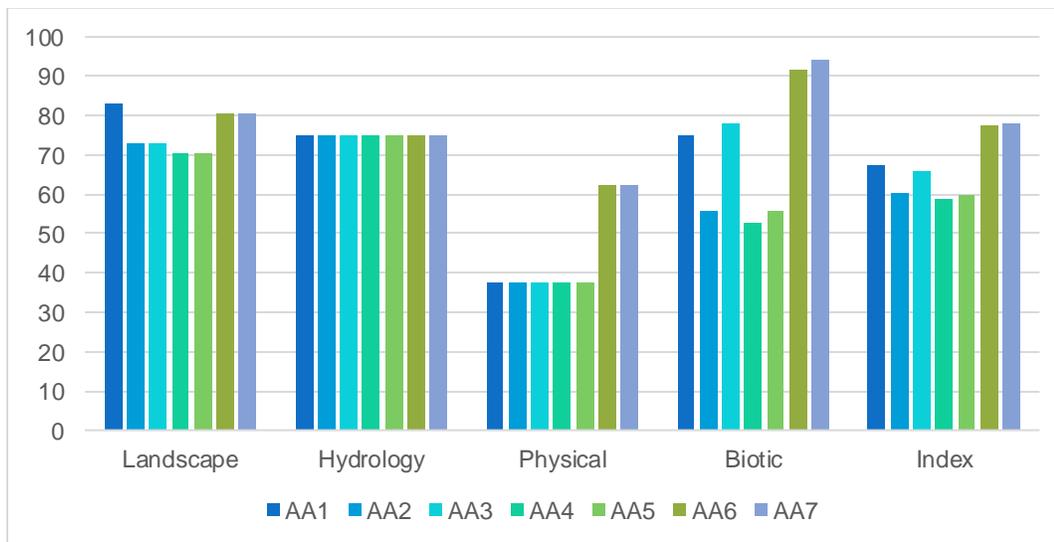
FIGURE 7. PRE-RESTORATION AND MAIN WATSONVILLE SLOUGH CRAM ATTRIBUTE SCORES

The main Watsonville Slough (# 6-7) scored much higher with Index scores of 77 and 78 as a result of higher Physical and Biotic Attribute scores (Figure 7). The main slough has been relatively undisturbed for much longer and has more complex vegetation and physical structure, while the pre-restoration area was disked within the last few years and has more invasive plants and less structural complexity.

Restoration Activities set for 2014 will most likely result in an increase in the Landscape Context (due to an increase in the amount of wetland area), Physical (due to the construction of the ponds) and Biotic (due to native planting and increased complexity in the landscape) Attribute scores.

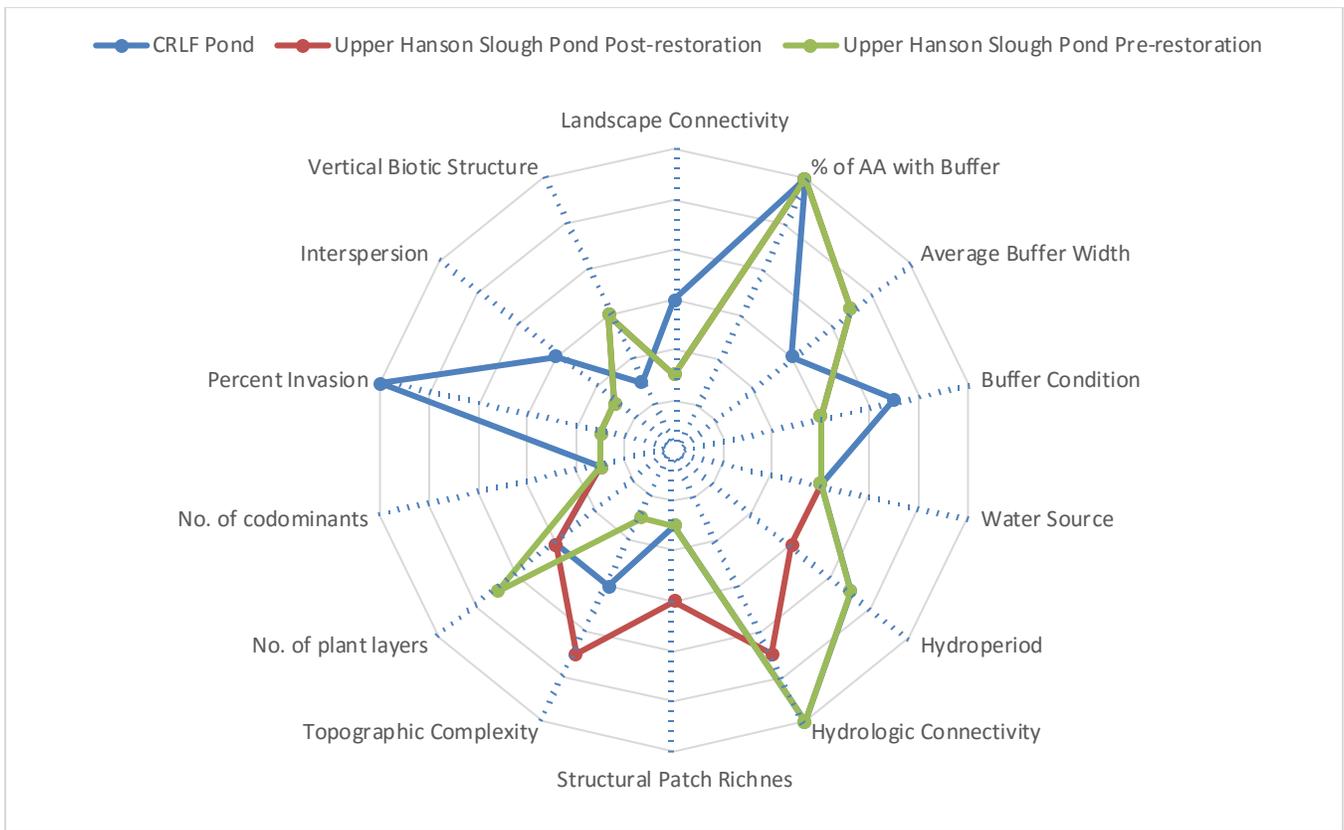
Results from the Upper Hanson Pond pre- and post-restoration assessments are shown on the spider plot (Figure 8). Pre- and post-restoration are shown in green and red, respectively. The red line shows where the score changed after restoration.

In general, the Landscape metrics remained the same, as the surrounding landscape and buffer hadn't changed significantly. However, there is opportunity for an increase in score through restoration of the grassland buffer to improve cover of natives and reduce disturbance.

Two of the Hydrology metrics (Hydroperiod and Hydrologic Connectivity) had reduced scores. CRAM is measured against a reference standard of a natural wetland, and wetlands that have anthropogenic manipulation will score lower on these Hydrology metrics.

The Physical Structure metrics both improved, with more Physical Patch Richness and more Topographic Complexity. Four patches were added to the pre-restoration list of patches, which originally included abundant wrack and swales. The post-restoration list included: animal mounds, cobbles or boulders (these can be anthropogenic), non-vegetated flats, and swales. The Topographic Complexity score increased because the grading of the pond created a "bench", or relatively flat surface above the bottom zone of the pond that can accommodate rising water and provide a gradual moisture gradient.

The score for the number of plant layers decreased because the restoration plantings hadn't yet been established and the remaining vegetation in situ was generally senescent. Most other scores remained the same, but there is more opportunity for improvement in the Biotic Structure scores as the restoration matures. The Plant Community, Interspersion, and Vertical Biotic Structure metrics will all likely see improvement over time.

The blue line on the chart represents the nearby California Red-legged Frog Pond, which was assessed in 2011 and can be viewed as a reference site target for the restoration of the Upper Hanson Pond. Both Percent Invasion and Vertical Biotic Structure were higher at the CRLF Pond, and it is likely that the condition at Upper Hanson will gradually increase over time.

FIGURE 8. SPIDER PLOT OF UPPER HANSON SLOUGH POND PRE- AND POST-RESTORATION, WHERE EACH SPOKE OF THE WHEEL REPRESENTS A METRIC AND THE DISTANCE FROM THE CENTER INDICATES THE MAGNITUDE OF THE SCORE.
