# Salinas River State Beach Dune Restoration Project

## Final Restoration & Monitoring Report

July 2019

Central Coast Wetlands Group  
at Moss Landing Marine Laboratories

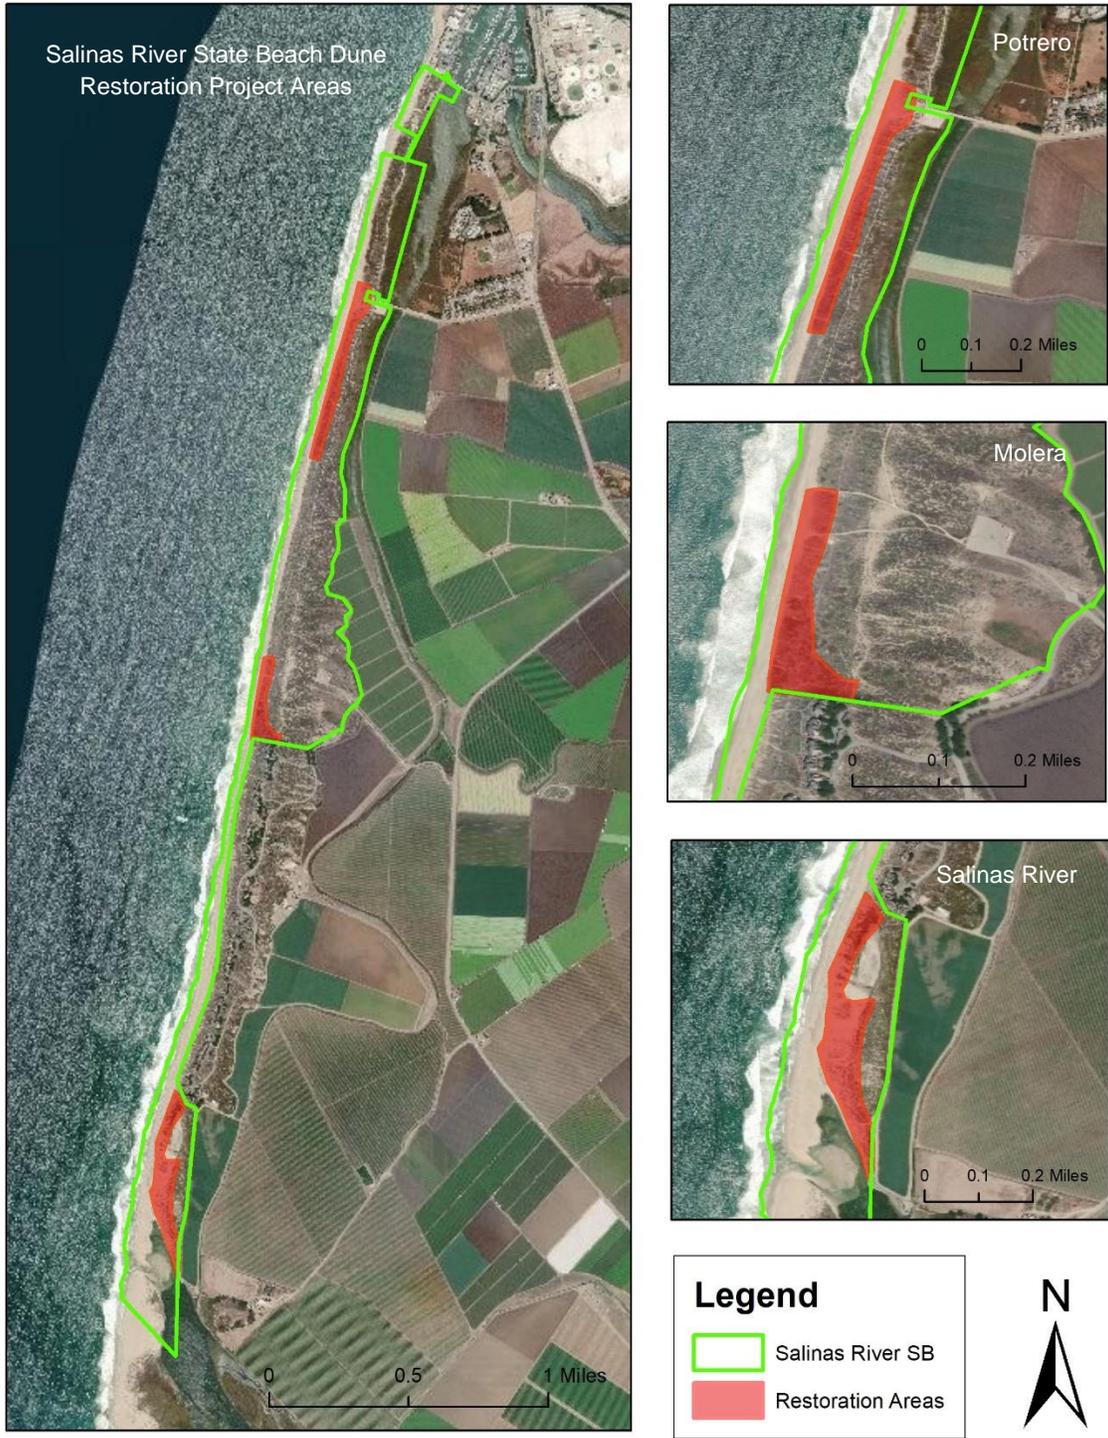
Figure 2. Project areas targeted for invasive species removal and reestablishment of native dune vegetation. Left panel shows overview of all sites. Three right panels show closeup of individual restoration areas (Potrero, Molera, Salinas River).

In 2015, the State Coastal Conservancy funded the Salinas River State Beach Dune Restoration project through the Climate Ready Grant Program. Since 2015, the Central Coast Wetlands Group (CCWG) has worked in partnership with California State Parks to restore 20 acres of sensitive dune habitat. The Project focuses on three areas within the dunes complex that have been identified as most vulnerable to sea level rise impacts (Figure 2).

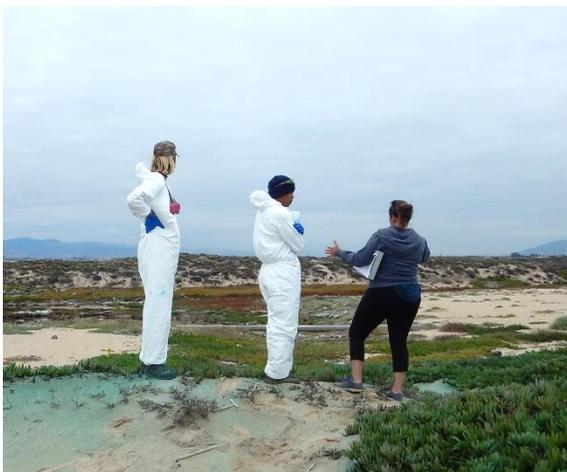
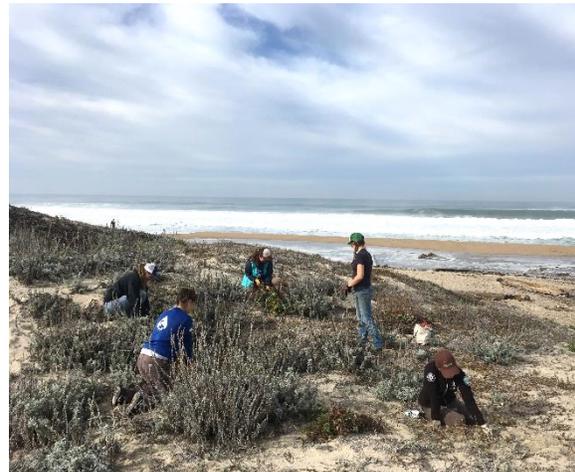
*Left: the herbicide application crew and project manager discuss iceplant locations to focus on for spraying efforts. Right: CCR and CCWG staff conduct an iceplant pulling day to remove any newly sprouted iceplant.*

During Fall 2017 (the second year of spraying), ECI finished applying herbicide to the entire project site. They also went back through the project site and spot sprayed locations where iceplant wasn't dead or was resprouting. Further, ECI cut and applied herbicide to *Arundo donax* near the Salinas River Mouth and sprayed a patch of invasive European beachgrass (*Ammophila arenaria*) near the Potrero Rd access.

During Fall 2018, ECI spot sprayed areas where iceplant had not died during the first two years or areas where resprouting was occurring.

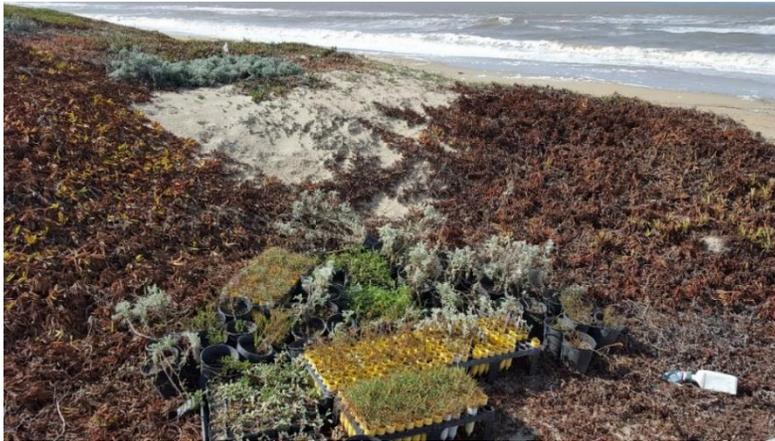
*Native plants in cones, rose pots, and gallon containers are staged for planting into the dead iceplant.*

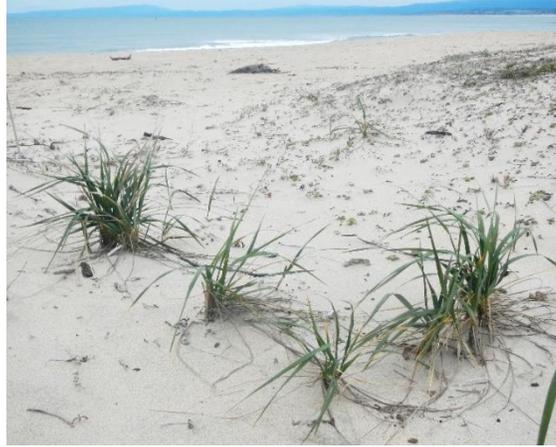
*Figure 3. Newly installed native dune grass helps capture sand in the foredune.*

The project team worked to restore 20 acres of dune habitat through eradication of iceplant and establishment of native species (see Goal 1 and 2 above). The project also included strategic planting of dune grass on the foredune and installation of hay bales and drift wood in a few select locations along the foredune in order to help capture sand, build dunes, and increase dune face resiliency (Figure 3 and Figure 4).

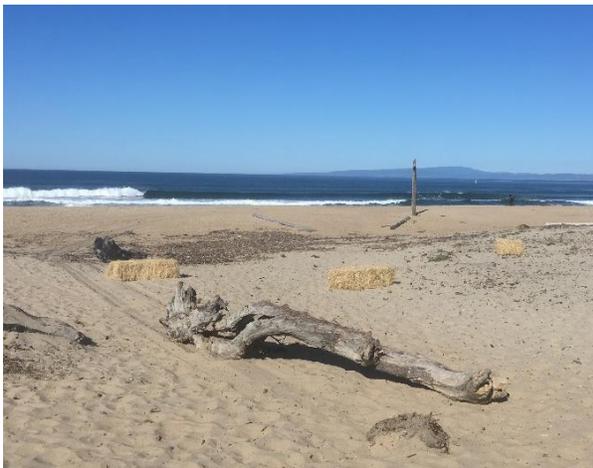
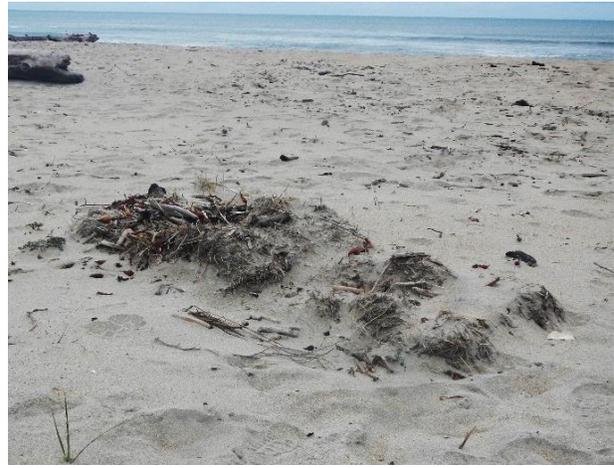
*Figure 4. Installation of drift wood and hay bales along the foredune help capture sand and increase dune roughness. Left: Initial placement of hay bales and driftwood near the Potrero Rd beach access trail. Right: After a few months the hay bales slowly decompose while continuing to help capture sand and add to foredune roughness.*

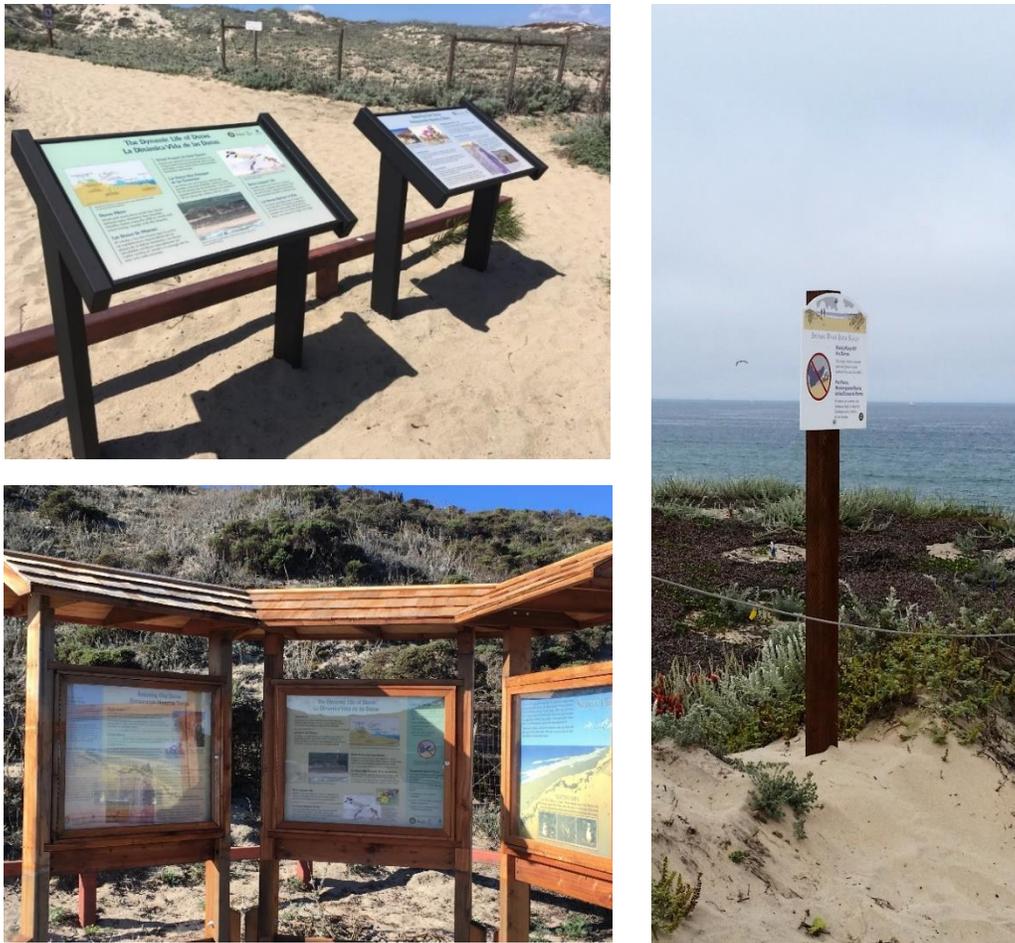
Figure 5. Interpretive and regulatory signage installed at SRSB. Top left: Wayside interpretive signs at Potrero Rd beach access parking lot. Bottom left: Interpretive kiosk installed at Molera Rd beach access parking lot. Right: "Please stay on trails" signage installed along dune trails.

Interpretive and regulatory signs were installed in 2017 and 2018 at beach access trails and along back-dune trails. The interpretive signs highlight the important functions of dune systems, sea level rise impacts, and the dune restoration process. Two wayside signs (24"x36") were installed at the Potrero Rd beach access parking lot and two larger panels (32"x40") and a 3-sided wooden kiosk were installed at the Molera Rd parking lot. Ten "Please keep off the dunes" regulatory signs were installed along beach access trails and along the back dune "horse trail" (Figure 5).

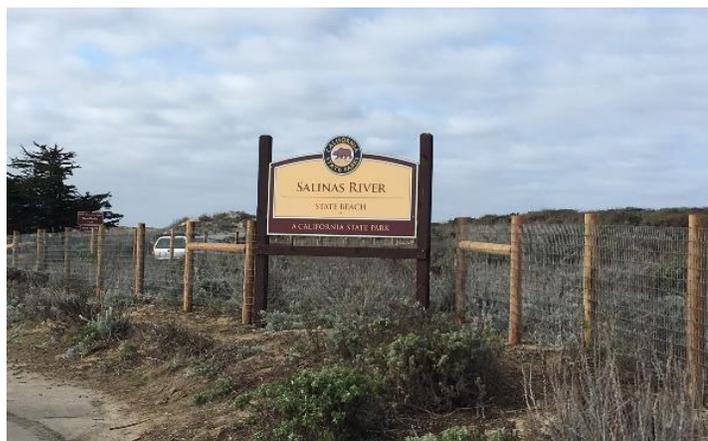
Figure 6. New no-climb fencing was installed along the Sandholdt Rd parking lot to reduce wayward foot traffic through sensitive dune habitat

Six hundred feet of no-climb fencing was installed along the Sandholdt Rd parking lot in 2017 and 2018. Fencing was designed with a 6 inch gap between the bottom of the fence and ground for small animals to easily pass through. This area was identified to be the priority for fence installation as it is where the dunes receive the most wayward foot traffic which disturbs dune topography and sensitive habitat (Figure 6).

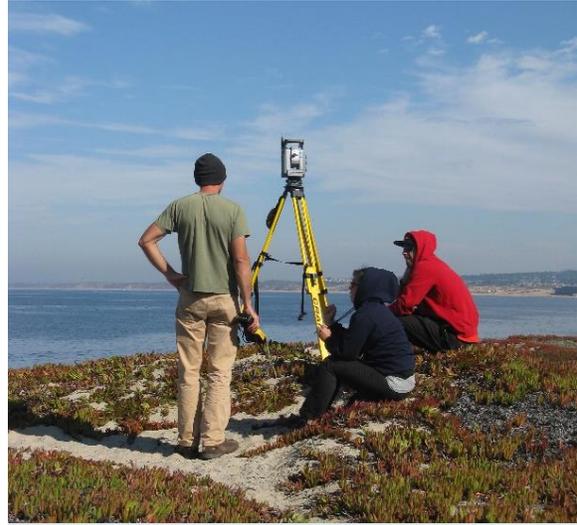
*Dr. Ivano Aiello and students surveying the dunes with the terrestrial laser scanner.*

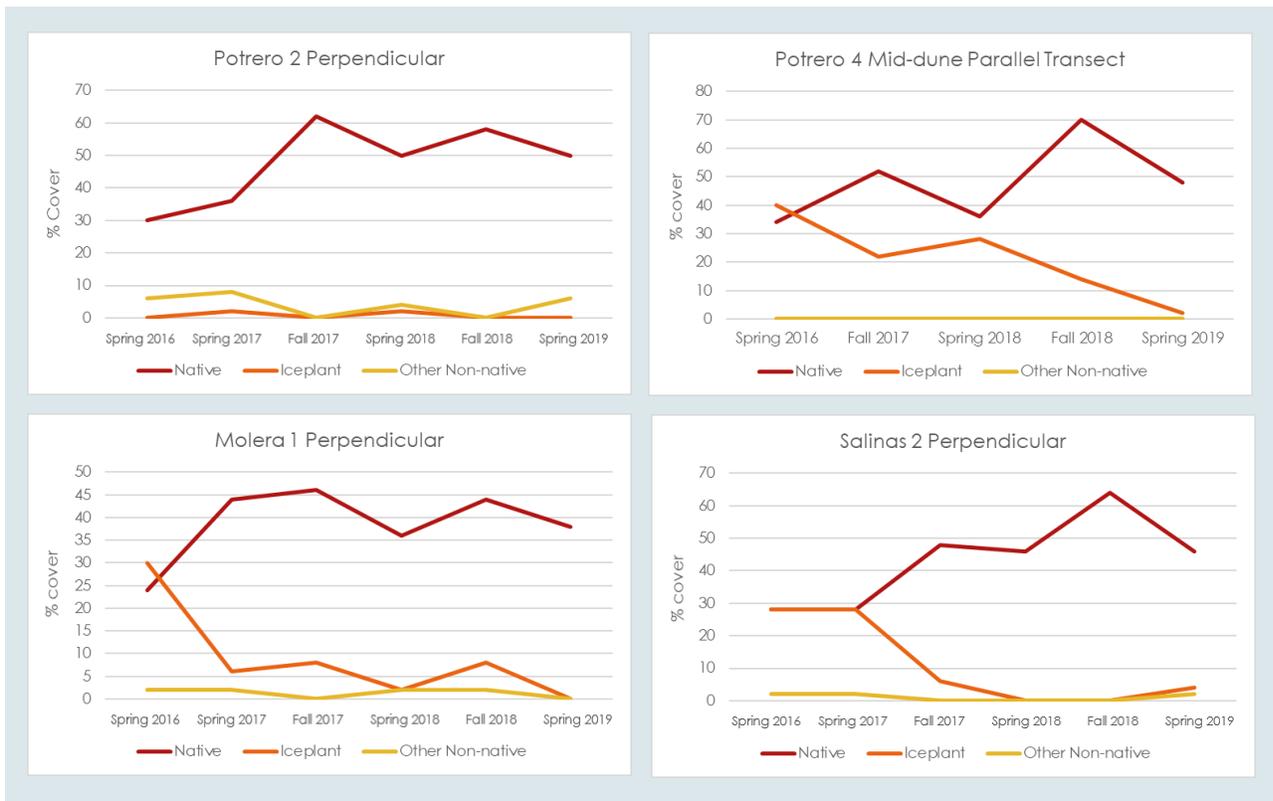
Figure 12. Changes in percent cover of native and non-native plant species along individual vegetation transect surveys over time.

Many of the individual transects document a similar trend of large decrease in iceplant cover and small increase in native cover. Some individual transects documented much higher increases in native cover (Figure 12).

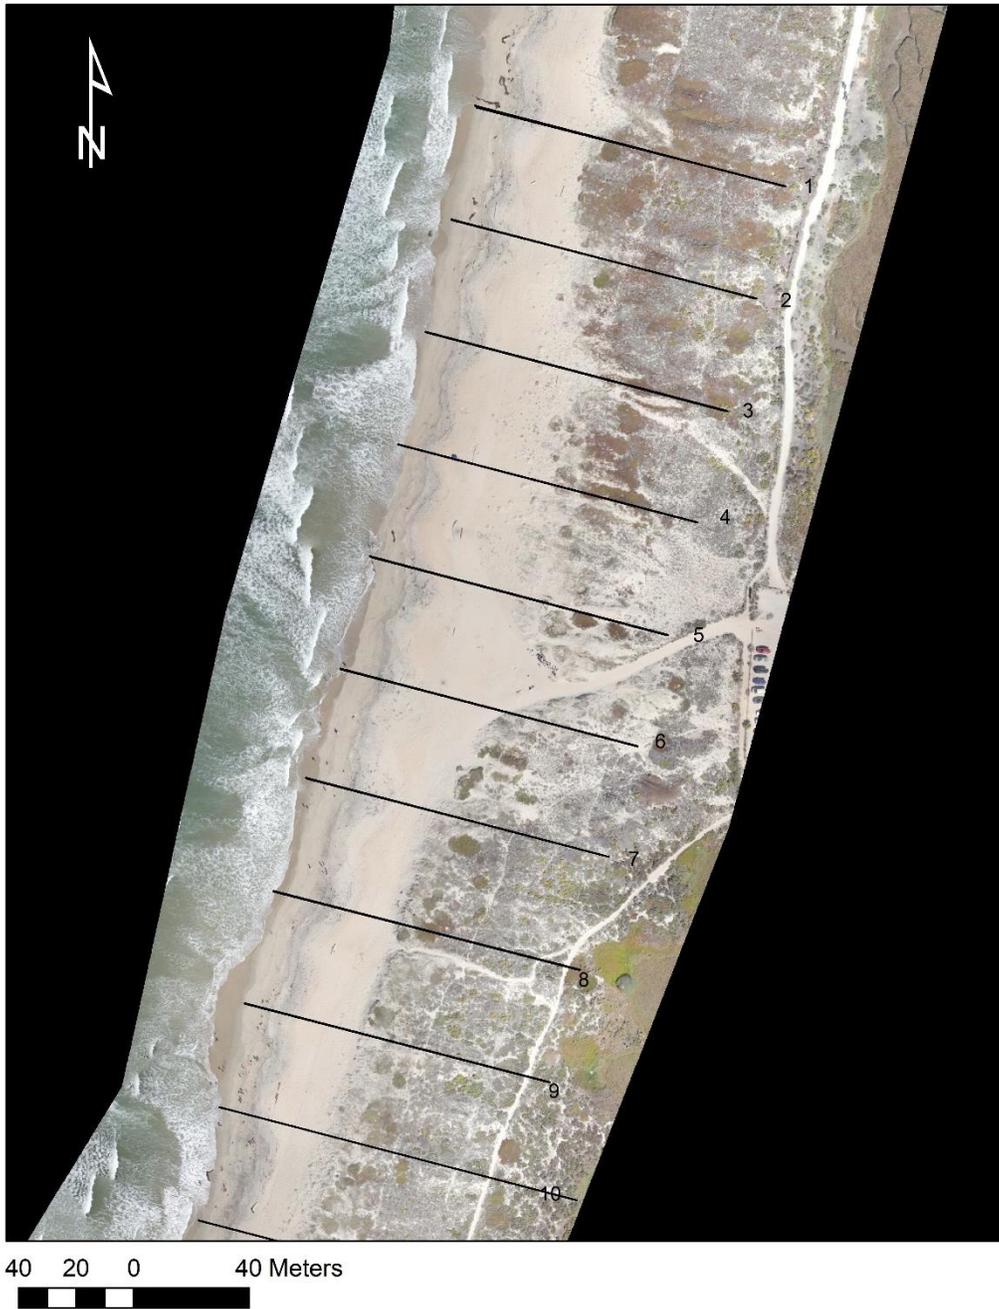
Figure 17. Imagery from UAV survey (2016). The lines represent the locations of cross sections used to assess topographic change for both unrestored areas and restored areas at the Potrero restoration site.

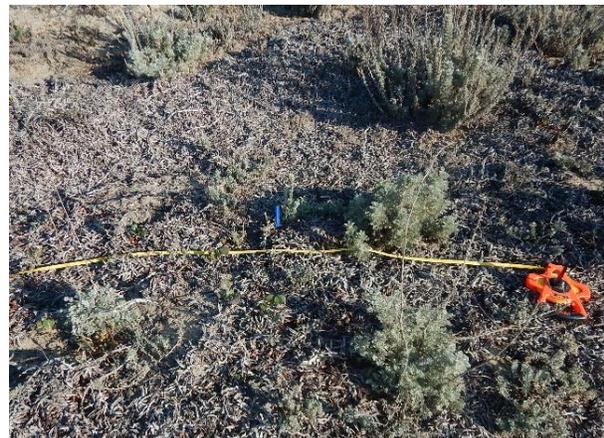
Figure 20. Example of Treatment Plot B. The photo shows the native sagewort planted within the dead iceplant mulch layer.

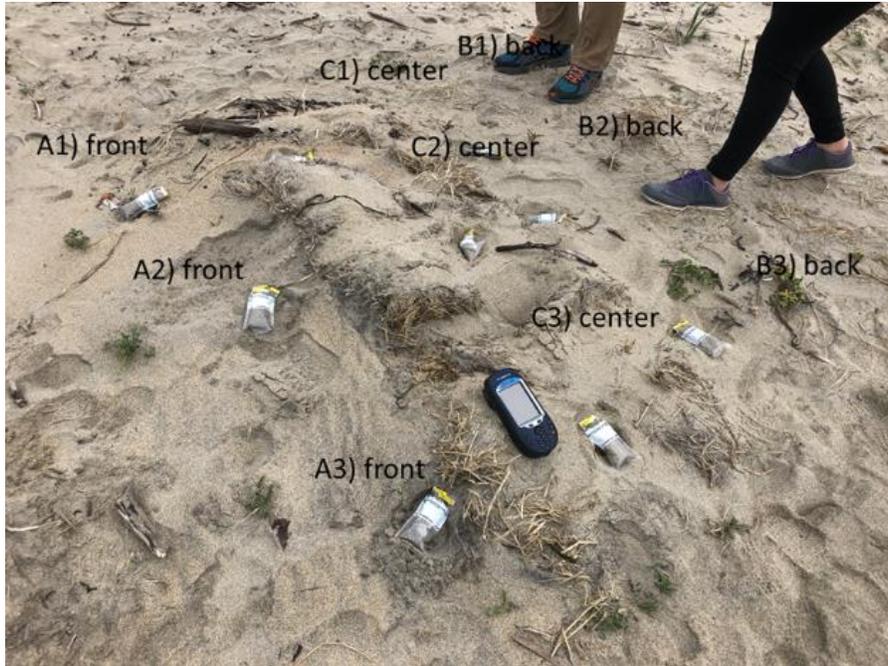
Figure 29. Results of the grain size analysis for hay bale #3. The Figure includes a photograph showing the location of the grain size samples in relation to the ocean (left) and the dune (right).
