Moro Cojo Slough NPS Implementation Project

Final Report
September 2003

Submitted to the Central Coast Regional Water Quality Control Board

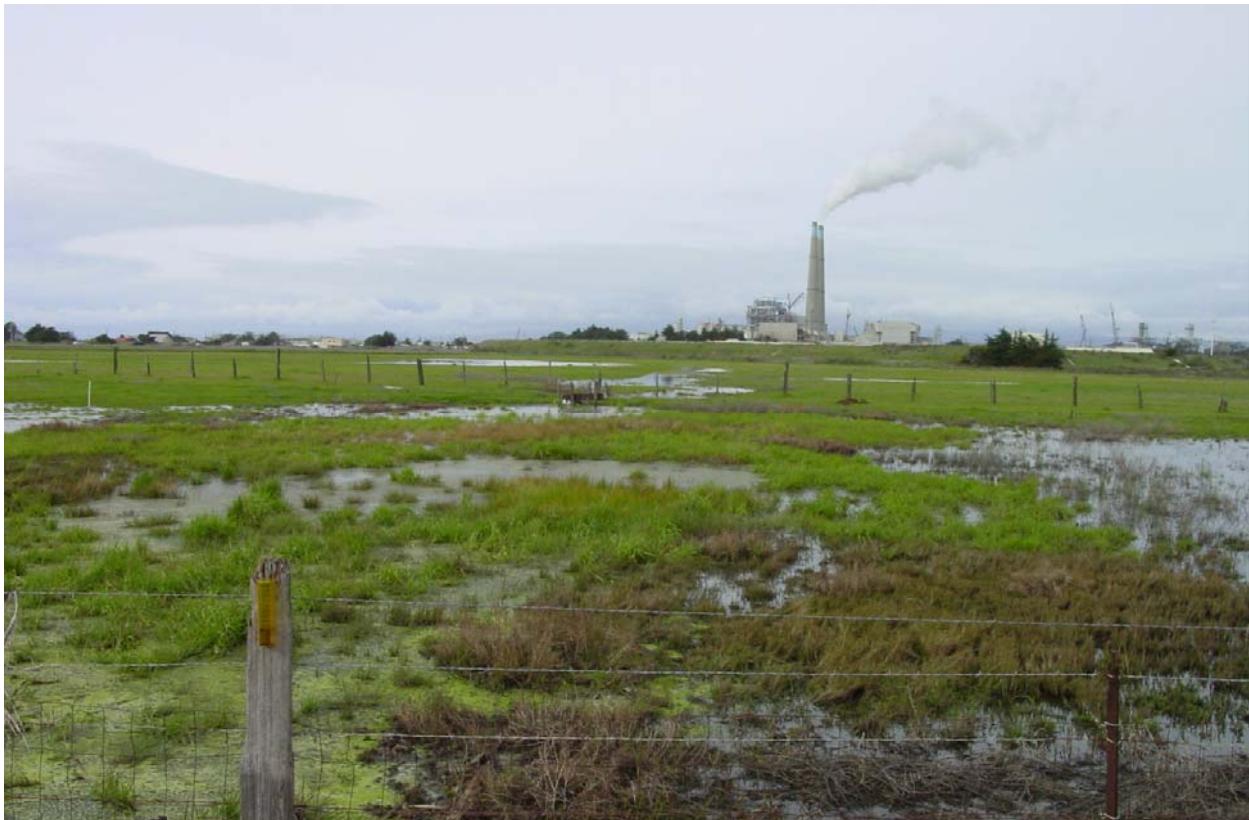
Figure 3. Ponds A and B, created by decommissioning ditches once used to drain the Moro Cojo Floodplain.

One of the most important landform changes we made during the initial phase of this project was the repair of the dike that isolated the ditch system from the main channel of the Moro Cojo Slough. This allowed us to impound virtually all of the water that flowed from the parcel itself, from the adjacent 200-acre farm to the south, and from the Tottino Ponds site. With the water on the site successfully retained in the ditch system we then identified areas where small earthen dams could be used to further decommission the ditch system and divert water into natural and excavated impoundments. First we blocked the large ditch that formerly drained the western side of the site forming two seasonal ponds, which formed over 6 acres of seasonally wet areas (Figure 3; Ponds A & B).

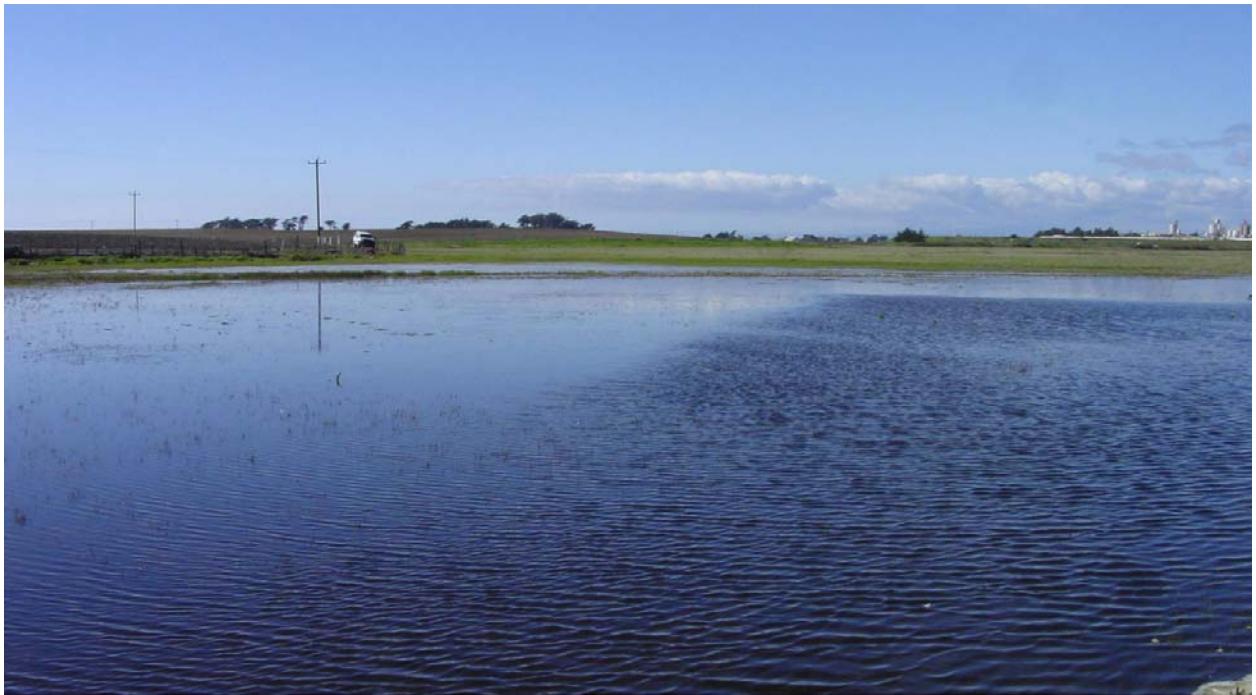
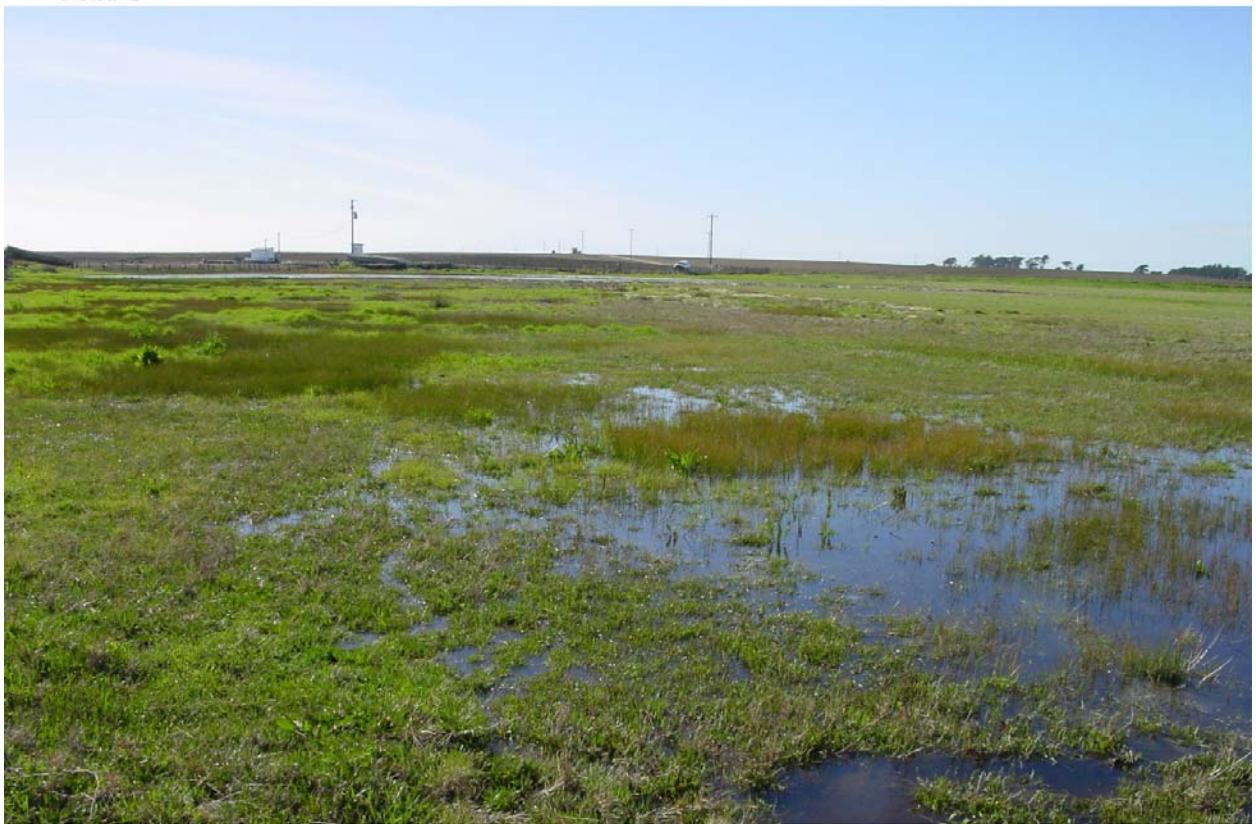
Figure 4. Ponds C and D created by repairing old dikes and filling with runoff and recycled from the adjacent farm.

The next important landform changes made at the Moro Coho floodplain site were the repair of two man-made ponds, which had been created by duck hunters sometime in the 1940s. These ponds, originally created by building small berms (~12 inches in height), however had long been drained and overtaken by non-native grasses. We found and repaired the places where the berms had been breached and filled the ponds with runoff from the adjacent farm (Figure 4; Ponds C & D), allowing us to then restore ~4.8 acres of wetlands in the former duck ponds.

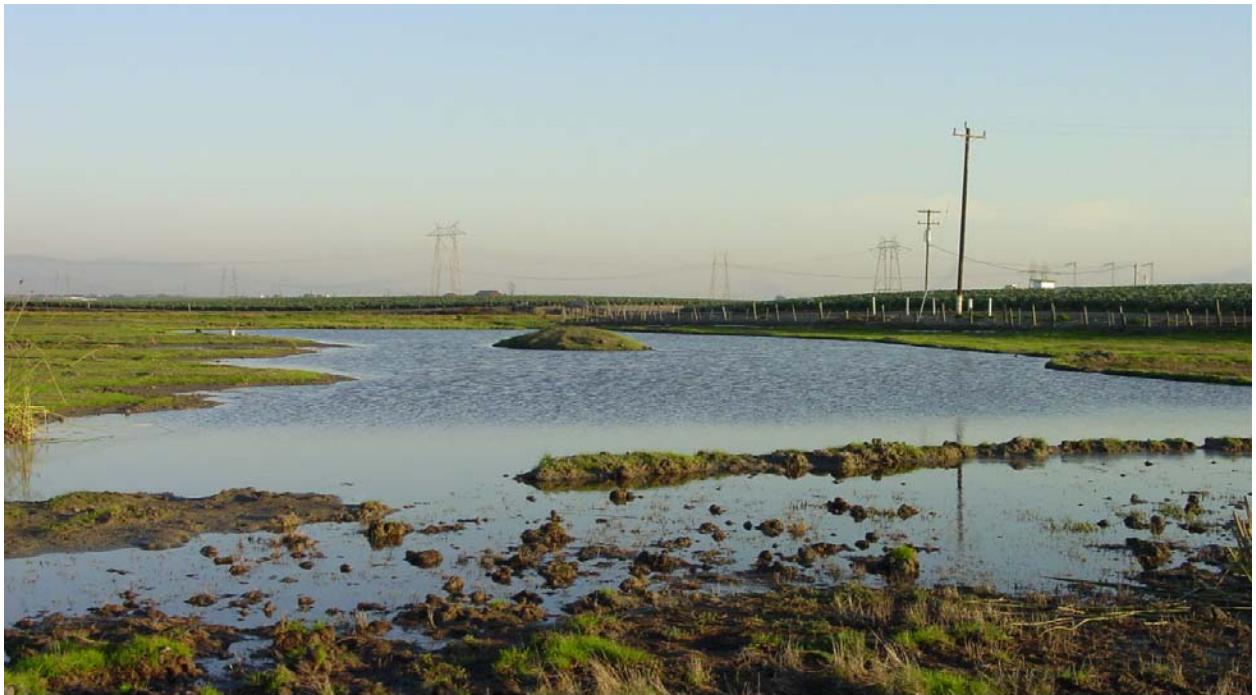
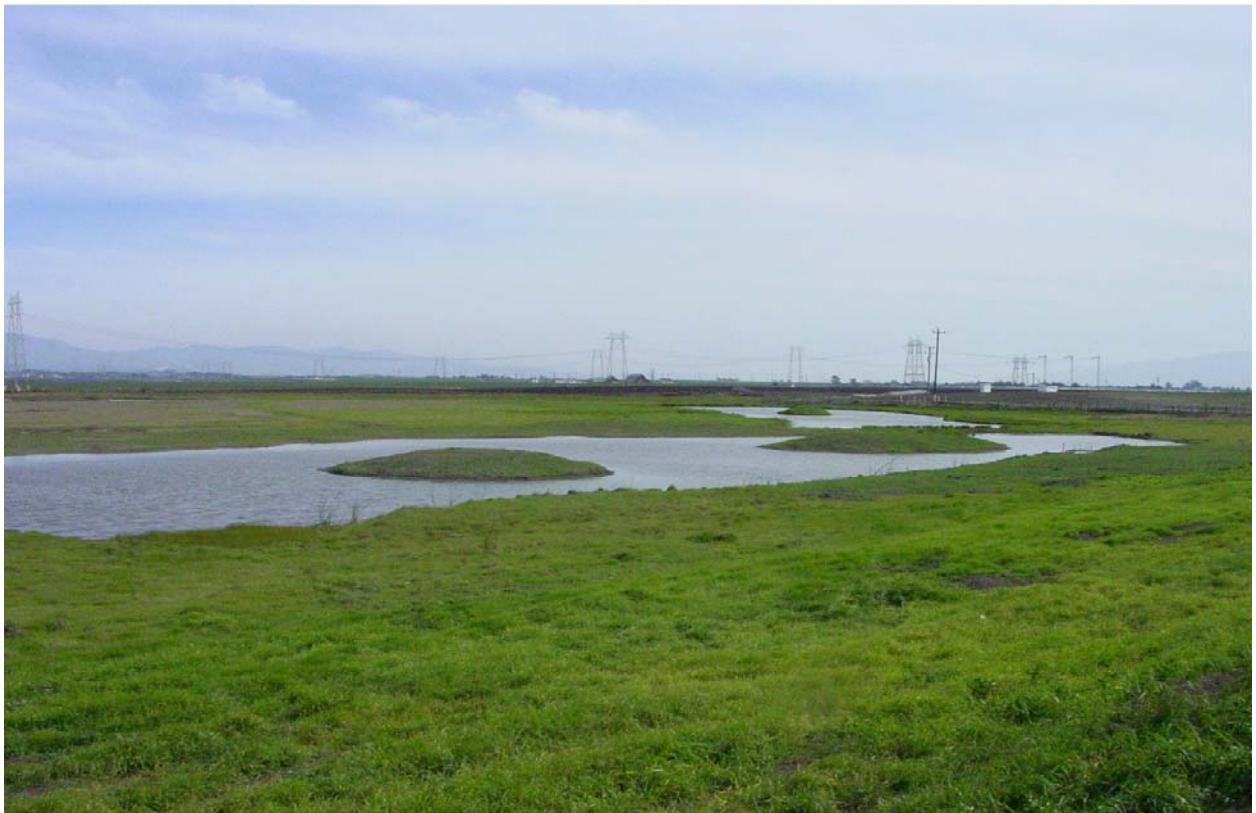
Figure 5. Ponds E and F created by excavating shallow basins in the non-native grasslands and filling with overflow recycled water from Pond C.

Nonetheless by using the natural gradients of the land we identified areas where shallow ponds could be excavated and flooded with recycled water that would also naturally fill under winter rain conditions. The first pond was excavated immediately west of Pond C. The location and dimensions of this pond (Pond E) were actually determined by the overflow from Pond C. The elevation of the connection between these ponds was such that the new pond (Figure 5) could be filled by bringing the water level up in Pond C, and would remain full even when we allowed the water level in Pond C to fall. Water from Pond E, then flowed north and we identified another area where an impoundment basin (Pond F) could be excavated, again by using the pattern of overflow (Figure 5). The total area covered by ponds E & F is over 2.0 acres.

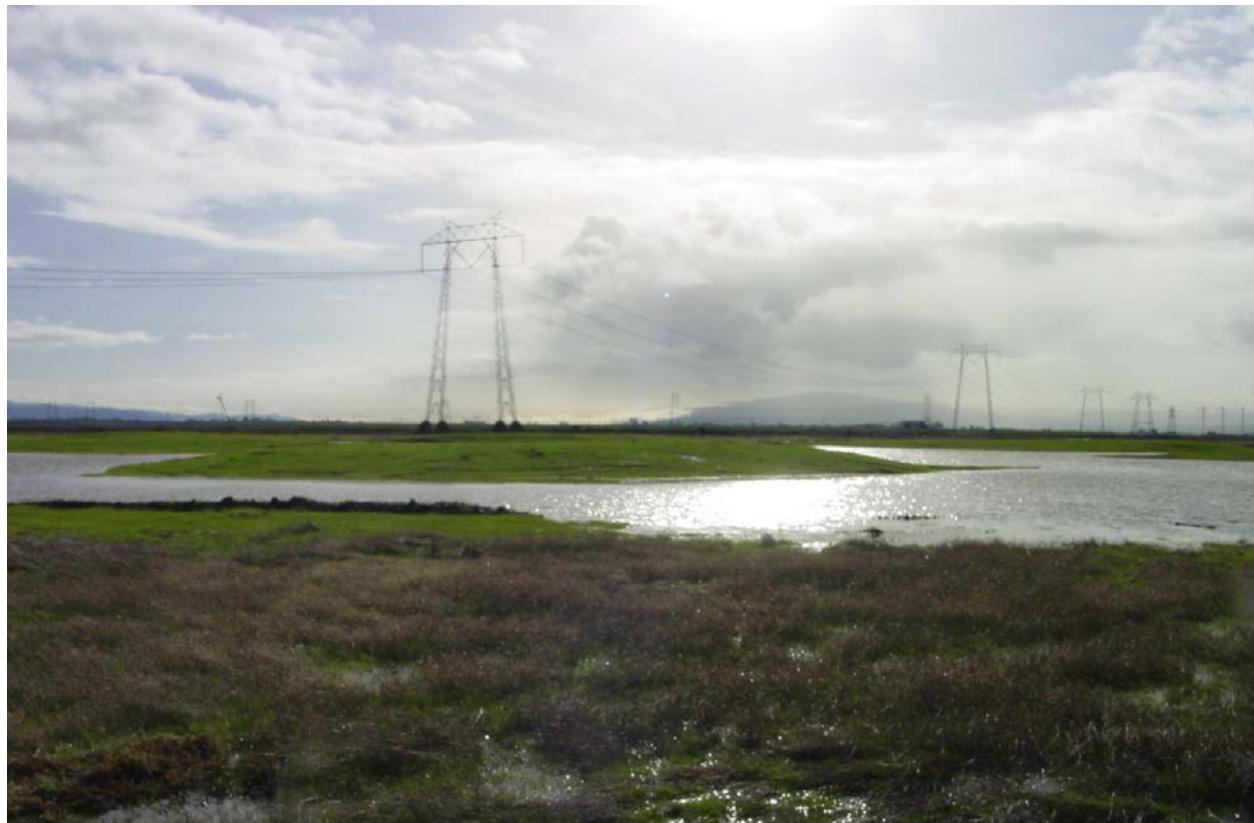
Figure 6. Pond G created by excavating a shallow basin and then filling with winter runoff diverted from the perimeter ditch system. Excavated dirt was used to create islands for nesting birds.

We then decommissioned the perimeter ditch with a small earthen dam, and excavated a narrow channel connecting the ditch to Pond G. During large rainstorms (more than ~3 inches), water backs up behind this ditch to the property's southeast corner creating sufficient head so that it flows into Pond G. During a rain event of this magnitude the entire pond can be filled to a depth of ~12 inches, and this water is unable to return to the ditch system. On the west edge of Pond G, we decommissioned the main central ditch in the same manner. We then cut a small channel (24" inches wide) between Pond F and the main central ditch, so that water can flow out of Pond F, through the channel, into the main central ditch and then into Pond G.

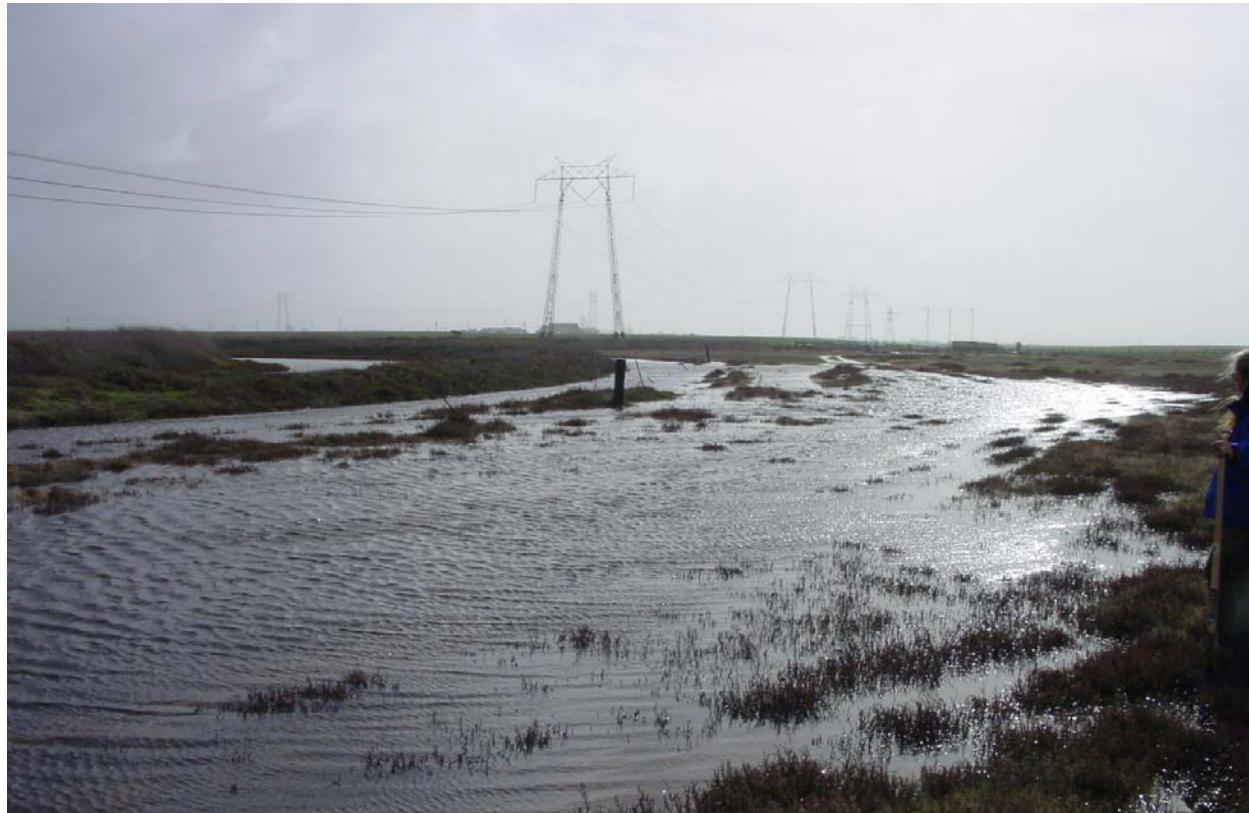
Figure 7. Pond H created with a diversion dam in the perimeter ditch system and filled with winter runoff from ~ 300 acres of farmland.

The diversion dam in the perimeter ditch created a large impoundment that extends from the dam to the southeast corner of the property, this 1.8-acre pond (Pond H) remains filled during the rainy months (Figure 7). The over flow from Pond H flows directly into Pond G. Ponds G and H capture virtually all of the runoff of ~300 acres of farmland, preventing this water from leaking into the main channel of Moro Cojo Slough.

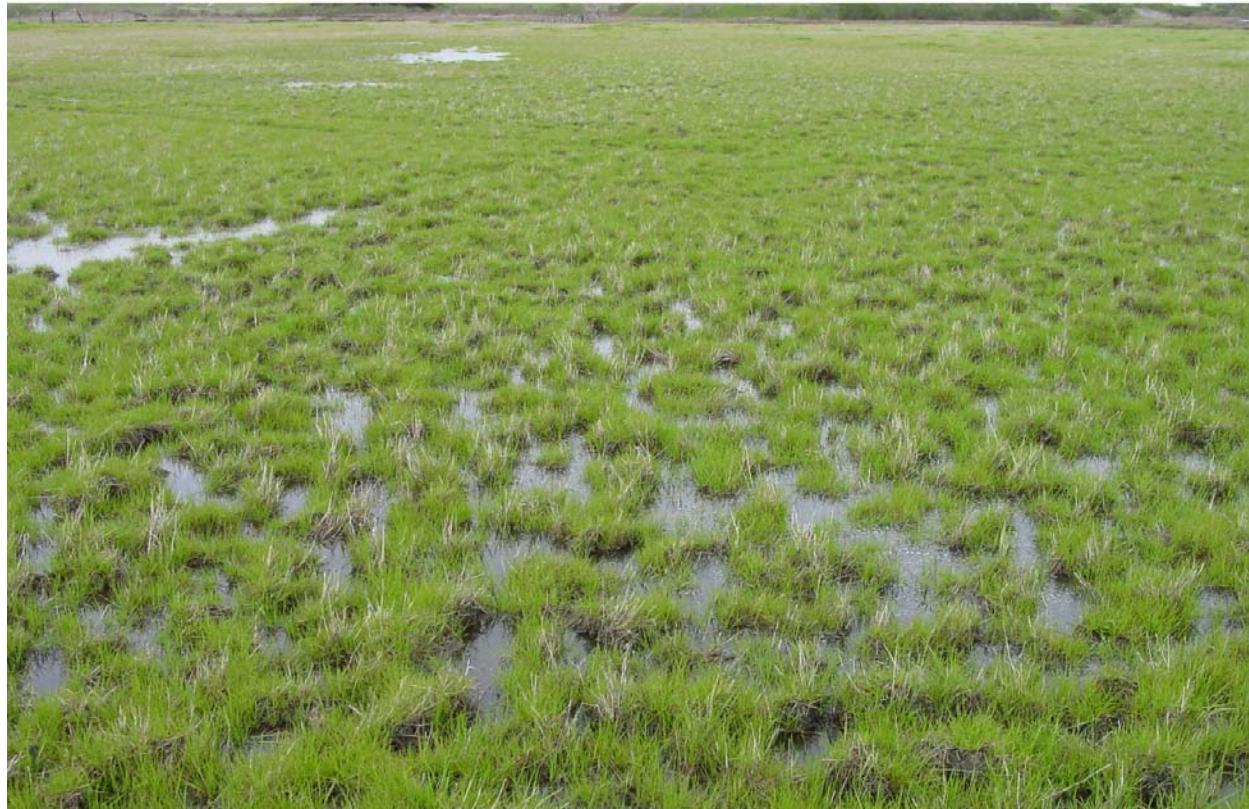
Figure 9. Large expanses of the grasslands retained water for long periods of time due to decommissioning of minor ditches formerly used to drain the site.

We also decommissioned numerous small-scale ditches that had been formerly used to drain smaller sections of the site. These required only a shovel but added significant areas of impounded water. During the winter rains we successfully impounded water over an additional 2 acres of the site by building these small dams and blocking the drainages, and vast areas of the site remained covered in 2-3 inches of water for long periods of time (Figure 9).

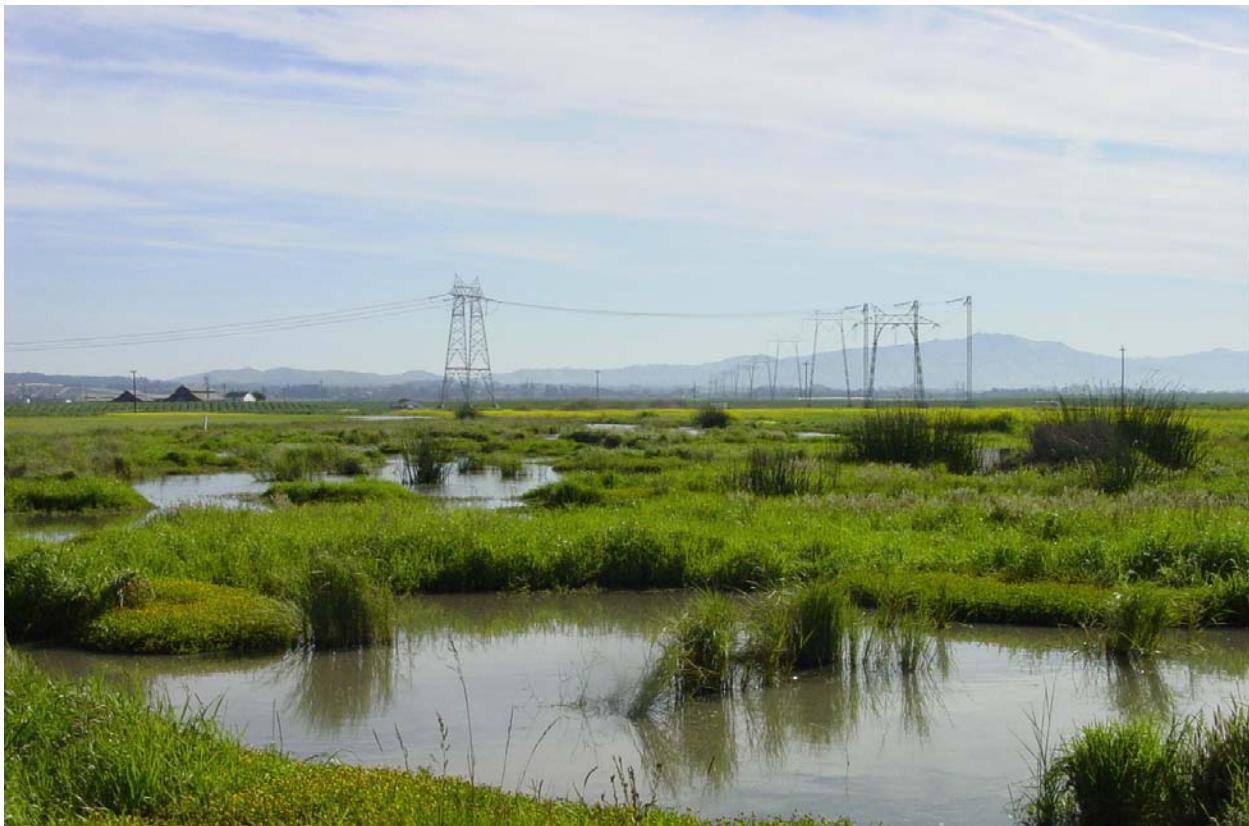
Figure 11. Pond 6 at the Tottino Ponds restoration site created by excavating a shallow basin in an area that had formerly been a barren disced field.

At the Tottino Ponds site the most significant landform change was the excavation of a sixth pond. This provided an additional 2 acres of open water and small islands surrounded by predominately native vegetation in an area that was formerly a disced barren field (Figure 11). The Tottino Ponds restoration site is just over 14 acres of which ~12 acres are permanently maintained as wetlands with recycled water.

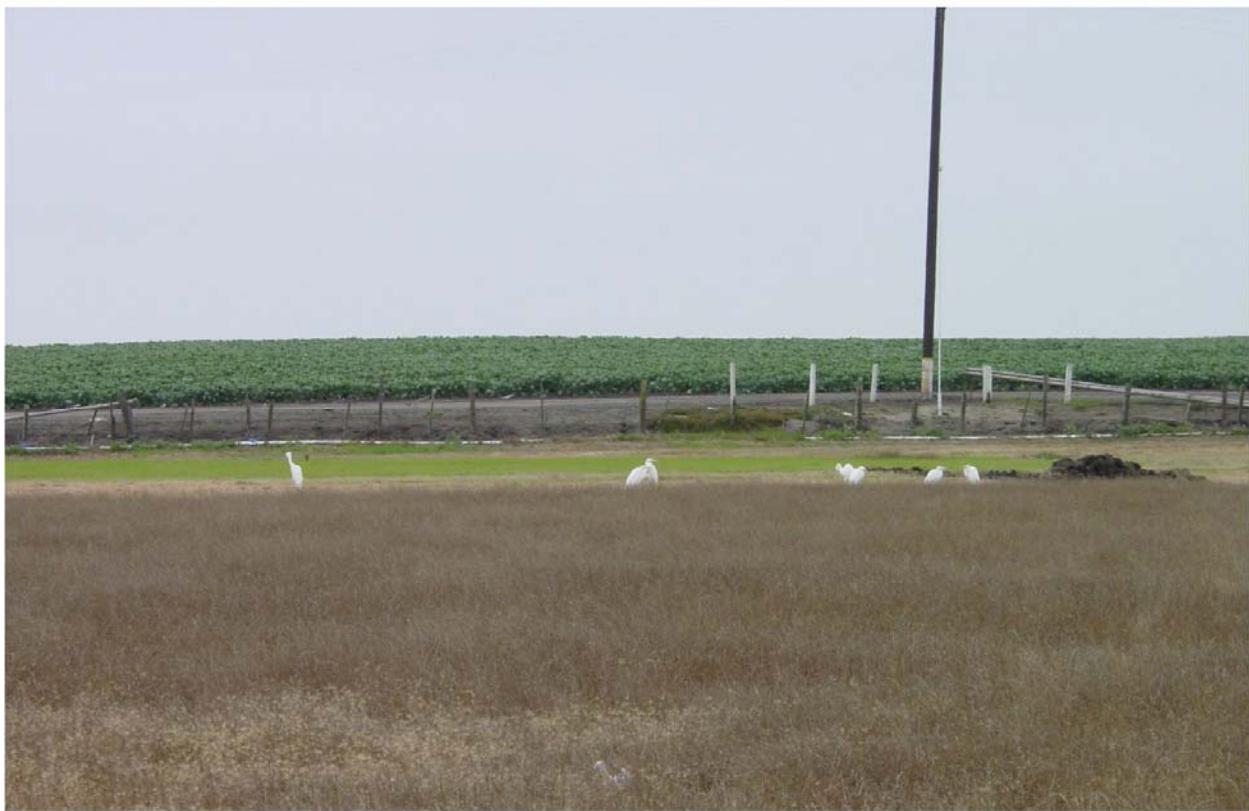
Figure 12. Mowed area along the shared boundary of the Moro Cojo floodplain restoration site and the farm, to control weeds and rodents by removing cover and attracting predators such as these Great Egrets.

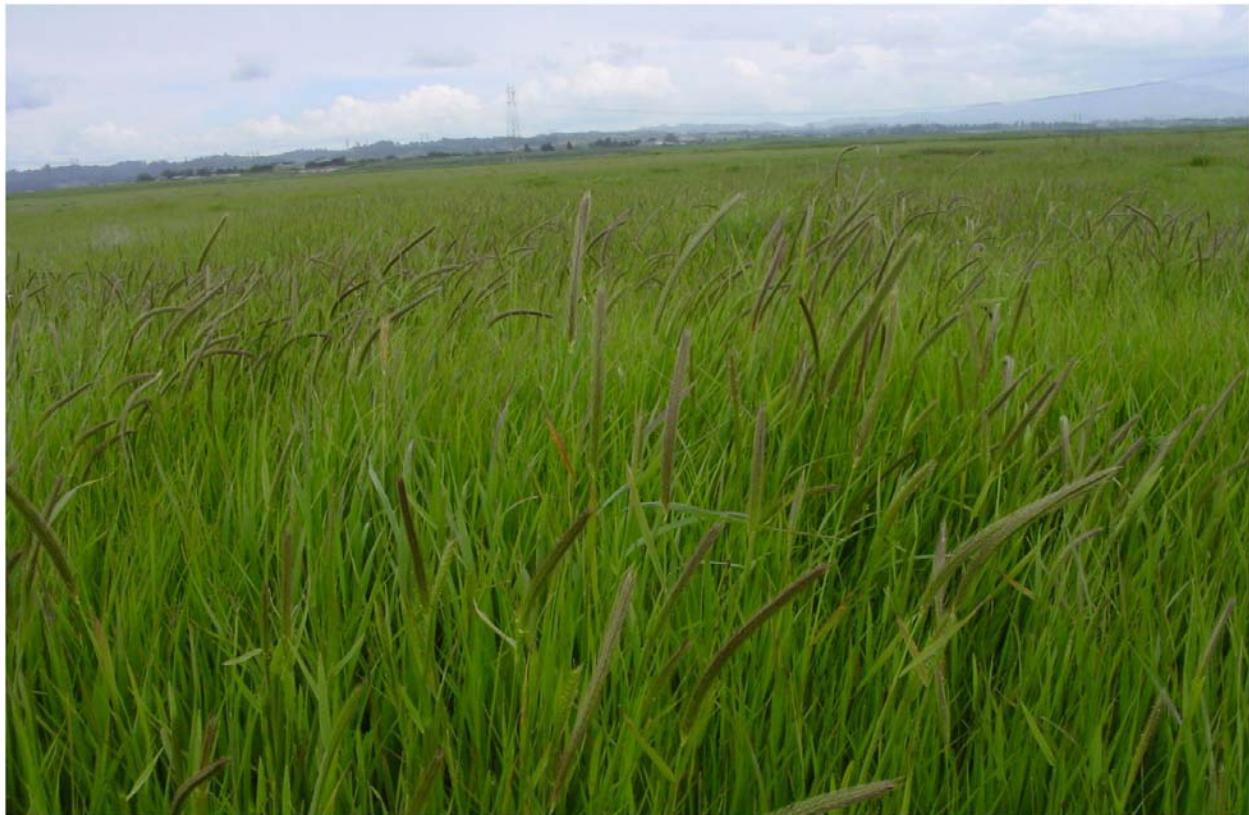
Figure 14. Stands of native meadow barley that recovered after mowing large areas of non-native grasses, which had prevented the proliferation of native species at the Moro Cojo floodplain site.

In other areas mowing several times each year encouraged the recovery of native plant communities. We mowed large areas covered by the Mediterranean grasses, to encourage stands of meadow barley (Figure 14) and creeping wild rye, both robust native perennial grass that add species and habitat diversity to an area and slows the proliferation of weeds.

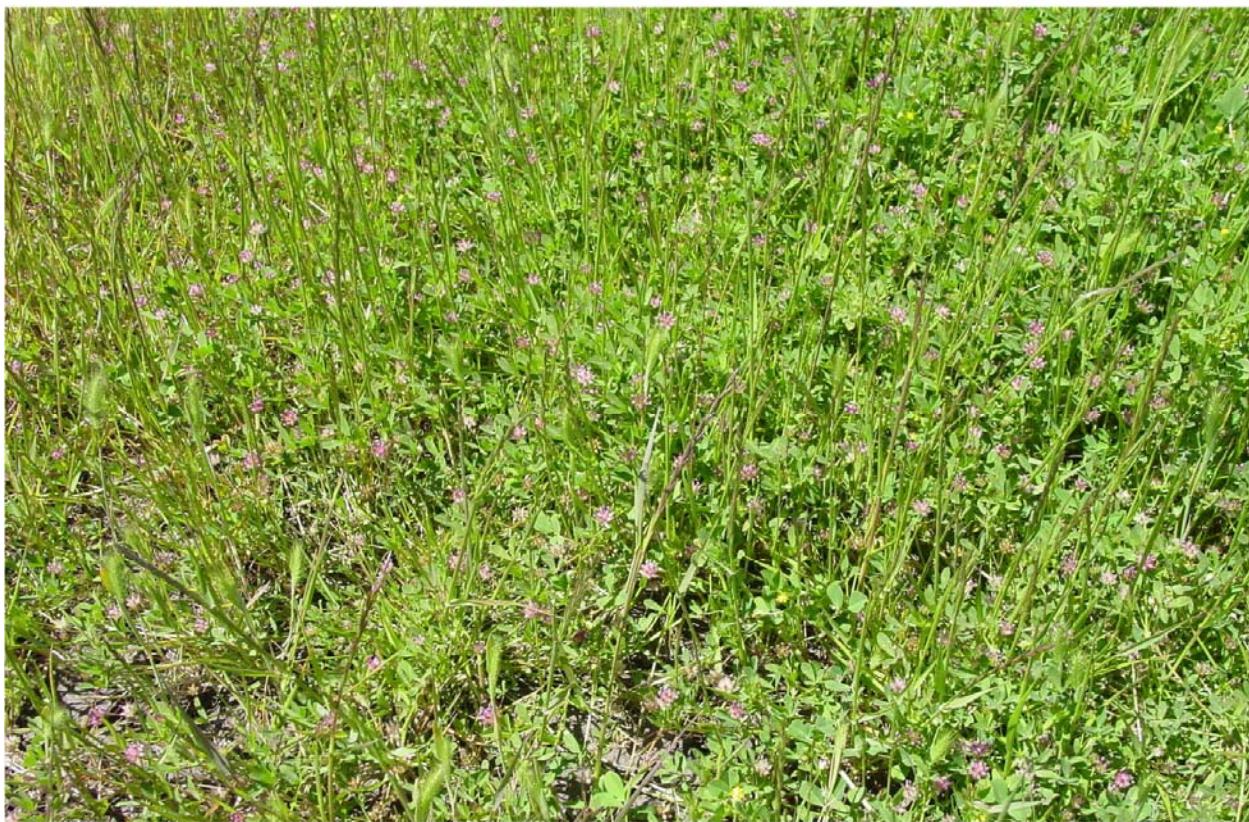
Figure 15. Once thought extinct, salt clover germinated and flowered where we disturbed the dense cover of non-native grasses

One of the most spectacular successes of this restoration with regard to native vegetation pertains to a small annual native salt (or sac) clover. This species was identified as “probably extinct” in Jepson Manual: Higher Plants of California (Hickman and Jepson 1993). Approximately 50 plants were discovered near this site in the past, and the California Department of Fish and Game Natural Diversity Database reports a small patch existed on the site although we had not seen the plant at the location they identified. In 2003, this clover germinated and flowered (Figure 15) at just about every location where we had disturbed the thick thatch cover of non-native annual barley and ryegrass. Virtually everywhere we mowed, every pile of dirt excavated when the ponds were dug, and even the simple road we use, was covered with this clover. In total we mapped over 14 acres of areas completely dominated by salt clover (Figure 13). Meter quadrat surveys indicated a plant density of 15 – 25 plants per square meter. Based on this we estimate a population of 950,000 to over 1,500,000 plants germinated, flowered, and seeded, significantly recharging the standing seed bank.

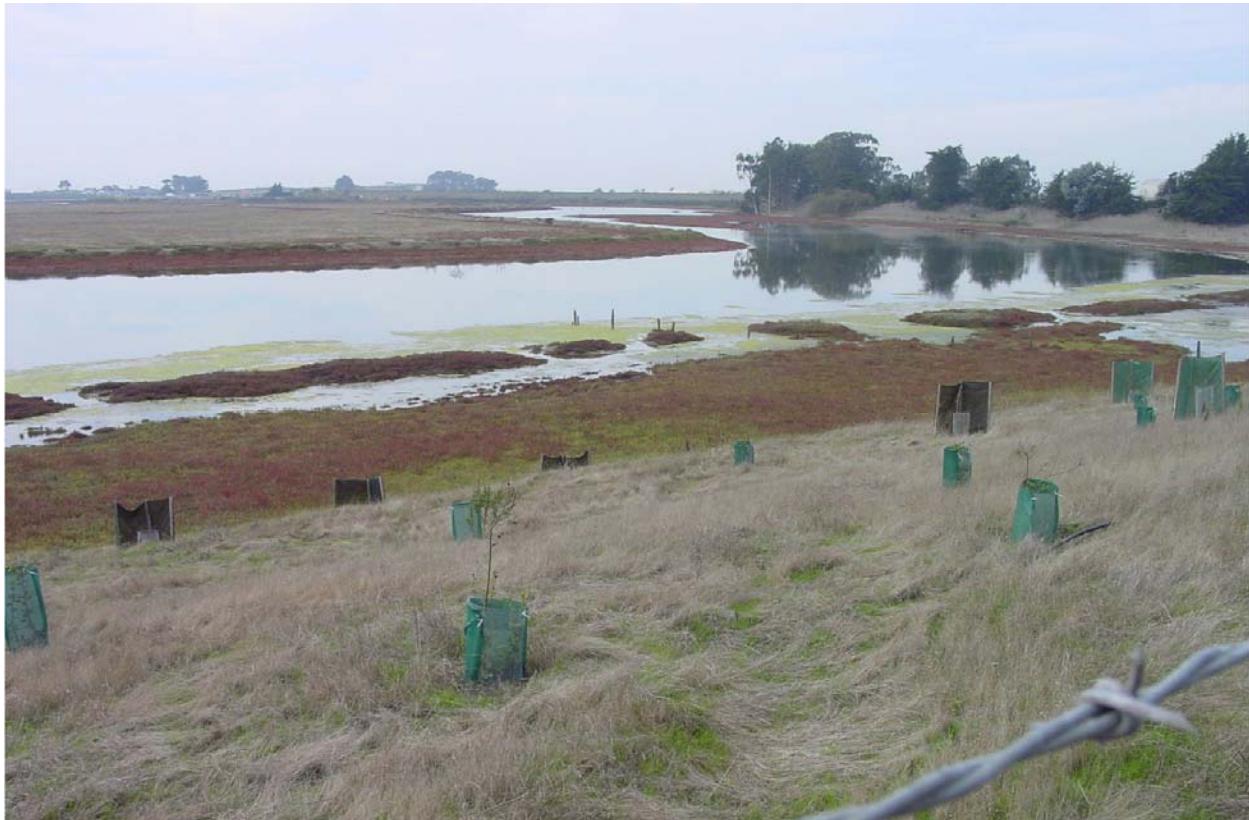
Figure 17. Oak trees planted on the slope at the Calcagno site to stabilize the slope and shade out weeds along Moro Cojo Slough.

The Calcagno lands that border Moro Cojo Slough are steep in some areas and had previously been grazed. After Mr. Calcagno had a fence installed to exclude the cattle from the step slope we planted coast live oak to stabilize the hill and shade out the weeds (Figure 17). We also planted numerous species at the restoration site on the Moon Glow Dairy north of Dolan Road. We have taken a slower, yet long term approach with these sites, planting slow growing trees that do not take considerable additional energy after the first 2-3 years. All totaled we have planted more than 140 trees, 77 shrubs, and 37 annual grasses and other annual herbaceous annual and perennial plants at the Moon Glow and Calcagno sites.

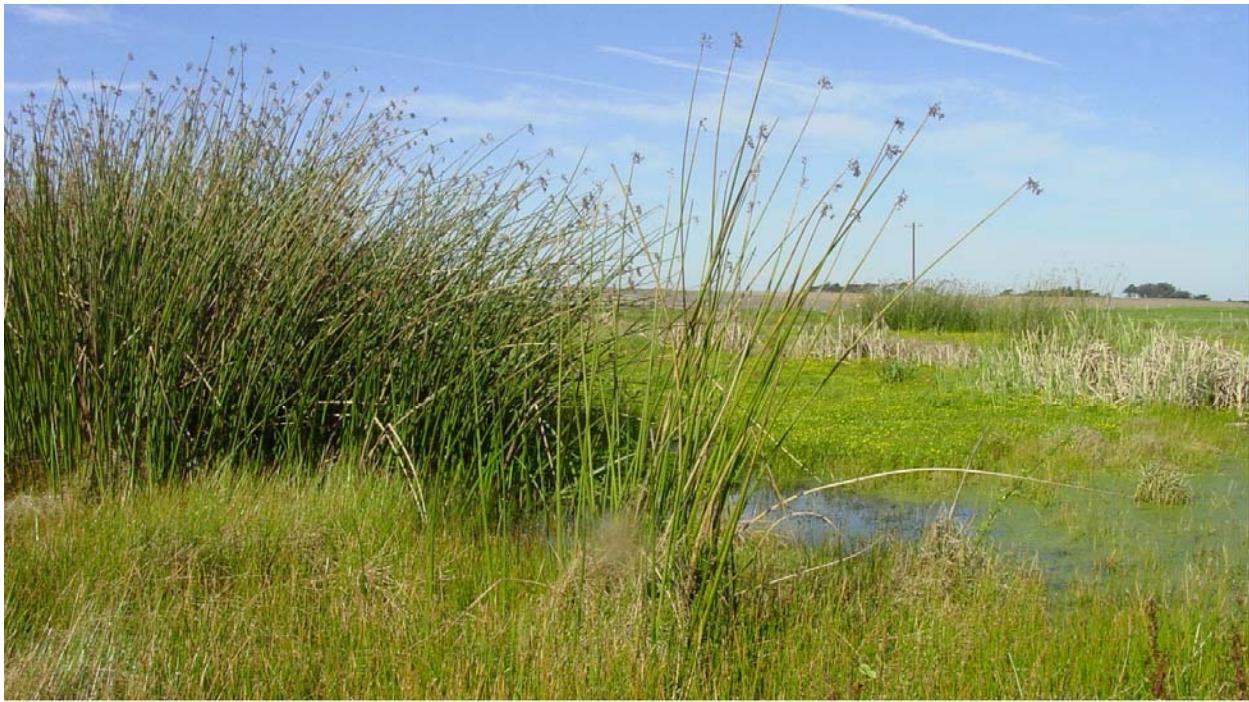
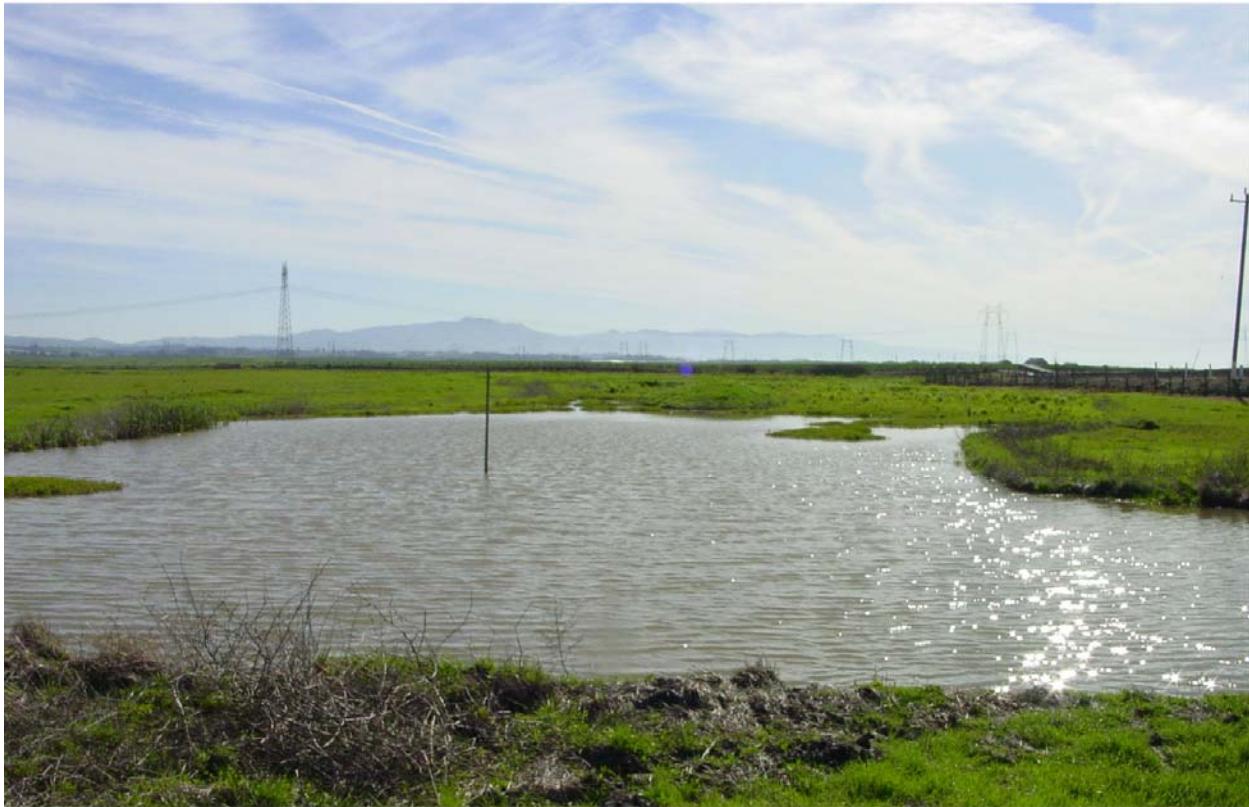
Pond C

Pond F

Figure 20. Impoundments at the Moro Cojo floodplain site contain both heavily vegetated (Pond C) and open-water (Pond F) components.
