Moro Cojo Slough

Agricultural Management Practice and Treatment Project

Summary

1996 - 2017

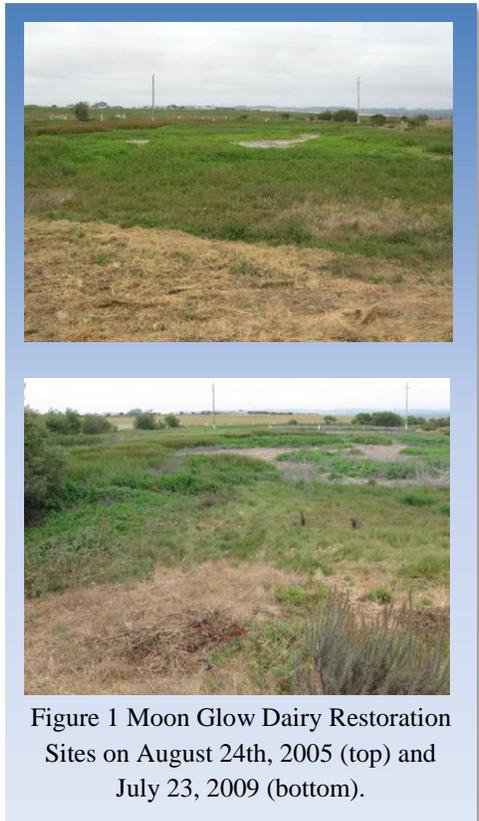
Figure 1 Moon Glow Dairy Restoration Sites on August 24th, 2005 (top) and July 23, 2009 (bottom).

The first restoration work at Moon Glow Dairy took place in 1996 when a low lying 2.6 acre portion of a grazing lot was fenced off from cattle. The area was in extremely poor condition and mainly served as a mud wallow for the cows. The area was expanded by 1 acre when the southeast corner of fencing was added in 1997. The fencing prevented cattle from grazing and trampling the area and allowed for the native seedbank present in the soil to re-establish a native wetland plant population. In 2002-2003, planting of native species began. Hundreds of trees, perennial shrubs, herbaceous plants and grasses were planted. Due to historical soil disturbance at this site, there are extensive amounts of weeds, especially in the upland areas. Weed management occurred over the entire site using weed whacking and hand pulling methods. In the corners of the site we planted additional native wetland and upland species. This assisted with weed management and generally increased the habitat value of the site for wetland fauna. The wetland and the surrounding buffer zone of native plants now acts as a filter for the dairy operations on the surrounding hillsides and improves water quality running into the Moro Cojo Slough.

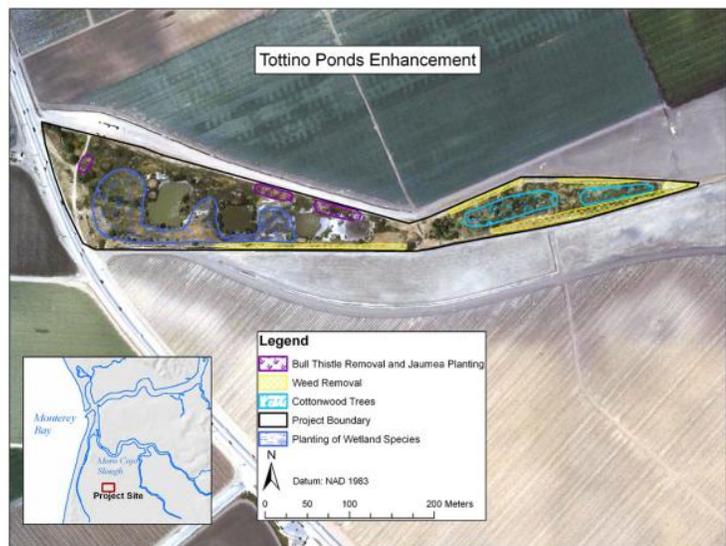
Figure 3 Overhead schematic of Tottino Ponds

The Tottino Ponds Restoration Project took place on 14 acres of land considered unsuitable for farming due to frequent flooding (Figure 3). The total project treats approximately 50 acres of farm runoff and sends treated water to an ag ditch that eventually flows into the Moro Cojo Slough (note: flow was later redirected to an adjacent wetland restoration project in 2016). The original site had been flat land covered with annual non-native plants. It had been regularly disced and baited with poison to prevent an excessive rodent population from invading nearby crops. Five ponds were created in 1999 by excavating shallow basins and pumping in water. Water was originally pumped to the ponds during restoration using a pipe system that brings recycled water to farms. An additional 6th pond was created in 2002 adding another 2 acres of wetland. Water is now sourced from groundwater, adjacent farm runoff, and road drainage. Weeds were removed by mowing, weed whipping and hand removal as well as flooding.

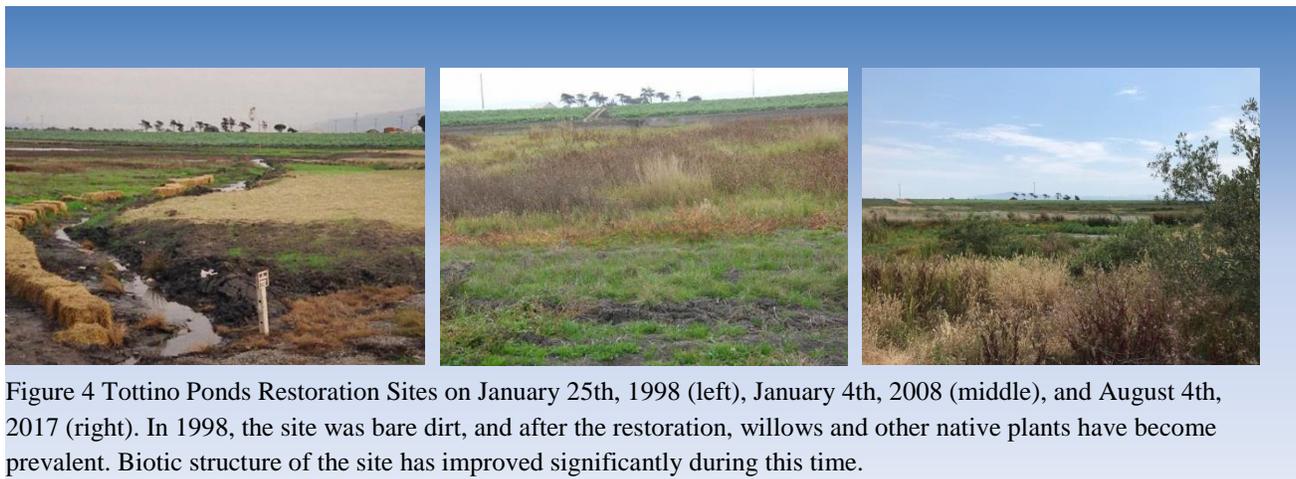
Figure 4 Tottino Ponds Restoration Sites on January 25th, 1998 (left), January 4th, 2008 (middle), and August 4th, 2017 (right). In 1998, the site was bare dirt, and after the restoration, willows and other native plants have become prevalent. Biotic structure of the site has improved significantly during this time.

Over the past twenty years this site has shown a dramatic transformation from a barren field to a fully functioning wetland ecosystem with breeding birds, threatened amphibians and a diverse freshwater invertebrate community. Ongoing weed management is needed to maintain the dominance of native plants. This is especially true along the edges, which come in contact with farm equipment. The newer ponds at the eastern end of the site have become overrun with rushes. These rushes die each year and create a dense mat of dead vegetation, ideal for rodent communities.

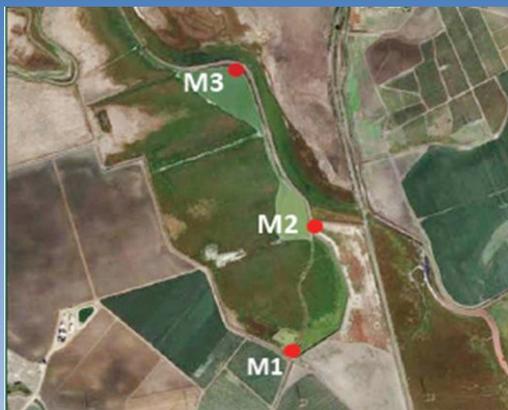
graph made with data from Dayton et al. 2008

Figure 9 Sea Mist Treatment Wetland nitrate levels at three different locations: M1 (upstream), M2 (midstream) and M3 (downstream). Results show that the wetland effectively decreases nitrate levels.

Water quality also improves as water flows through the treatment wetland. Nitrate at the inflow was measured at a concentration of 40 mg/L while nitrate at the outlet was measured at a concentration of 10 mg/L. Flow also varies throughout the wetland, and this varied flow rate can be used to determine the mass removal of nitrate. At Mid 1, $45.9 \text{ mg/l} \times 98,412,829 \text{ L} = 4517 \text{ kg}$ of nitrate were present. At Mid 3, $4.4 \text{ mg/L} \times 98,412,829 \text{ L} = 433 \text{ kg}$ of nitrate were present. The result is a net loss of 4084 kg of nitrate.

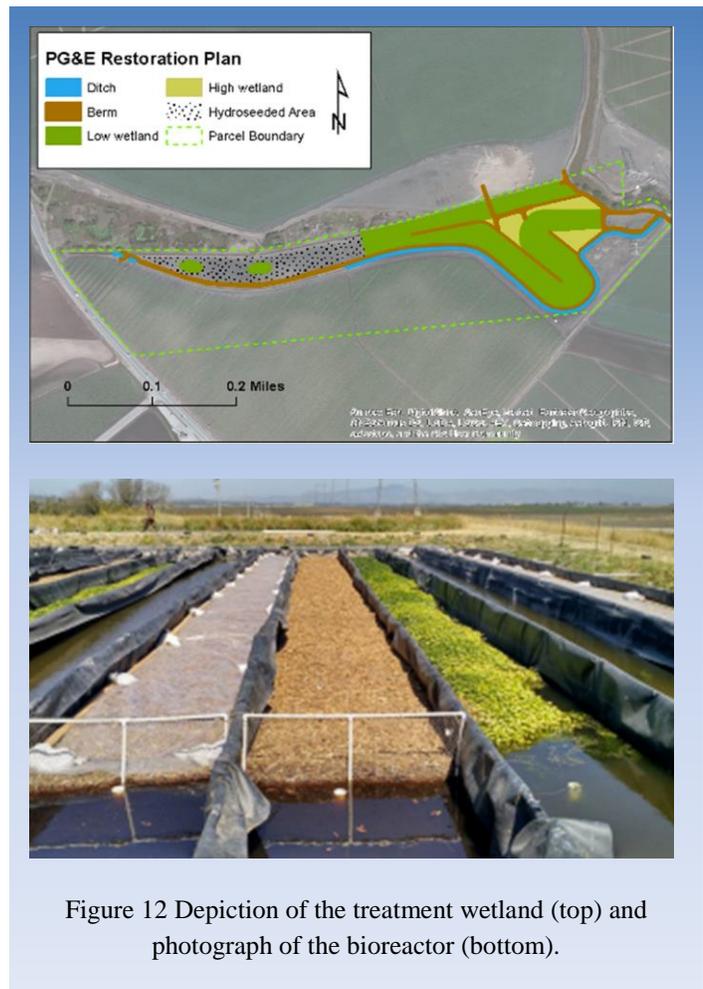
Figure 12 Depiction of the treatment wetland (top) and photograph of the bioreactor (bottom).

The PG&E treatment wetland covers 12 acres of land in the Moro Cojo watershed. Inlet water is pumped from the Castroville Ditch which drains approximately 1000 acres of farmland, predominantly artichokes and brussel sprouts into the PG&E experimental bioreactor, which is located at the head of the PG&E Treatment Wetland. Water is then gravity fed through a 1.25 km sinuous channel with built in depressions and ponds that support wetland plants and habitats, leading to substantial denitrification for agricultural water. Treated water flows back into the Castroville Slough about 200m downstream of the inlet. The treatment capacity is estimated at 80,000 gallons/day, the average hydraulic retention time is four days.

The PG&E experimental bioreactor is a twelve chamber treatment for incoming agricultural runoff from the Castroville

ditch. The bioreactor contains three different treatments and one control, with three channels of each. The treatments are woodchip bioreactor, heated woodchip bioreactor, and floating aquatic vegetation (*Hydrocotyl*). After flowing through the bioreactor, water flows to the PG&E treatment wetland.
