# North Monterey County Amphibian Habitat Enhancement Project

Interim Monitoring Report

August 2019

Central Coast Wetlands Group  
at Moss Landing Marine Laboratories

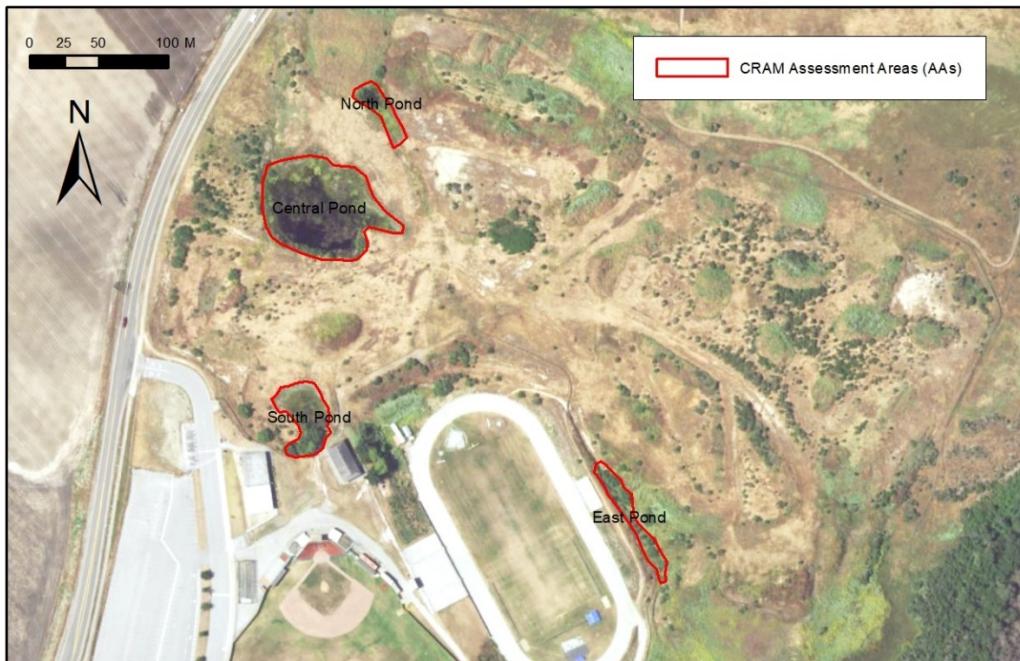
**Figure 1. CRAM assessment area (AA) boundaries at the North Monterey County Amphibian Habitat Enhancement Project (conducted October 2017, May 2018, May 2019).**

CCWG conducted CRAM at each of the 4 ponds (Central Pond, East Pond, South Pond, North Pond) in September of 2017, May of 2018, and May of 2019 (Figure 1). The September 2017 CRAM was conducted pre-ground engineering, planting, and vegetation removal. CRAMs conducted in May 2018 and May 2019 represent post-ground engineering and some planting.

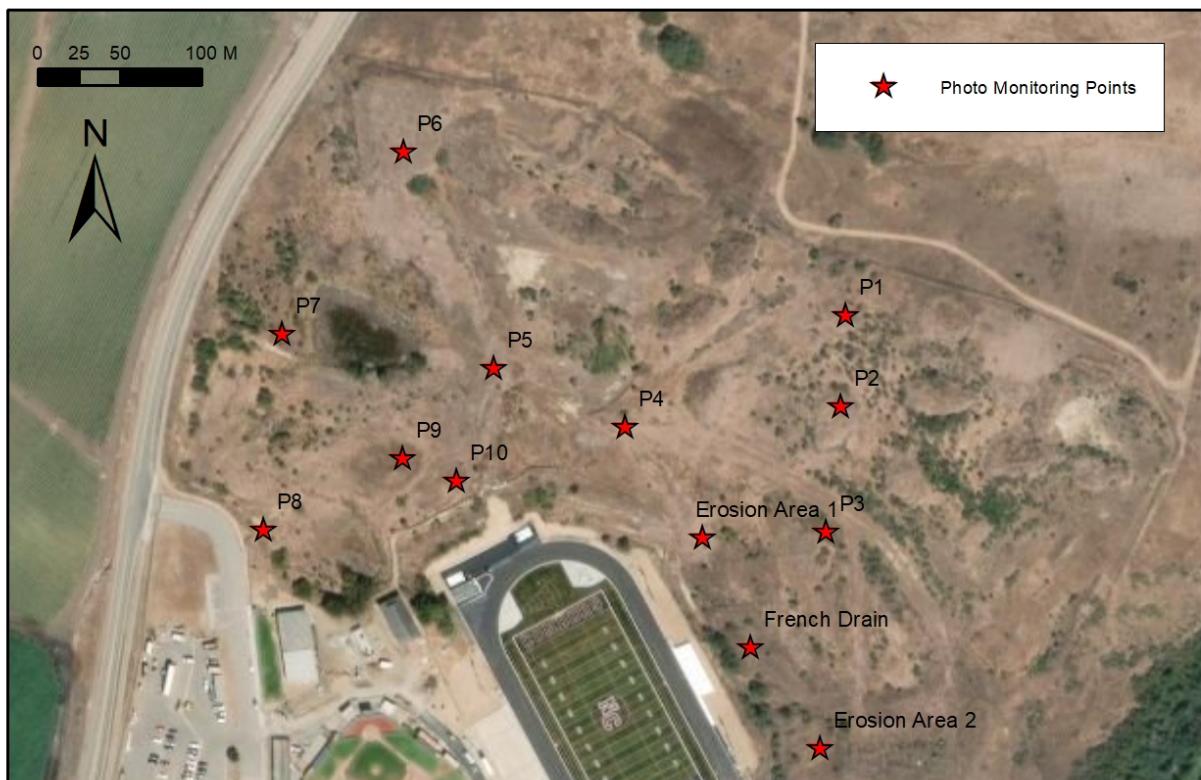
Figure 14. Photo monitoring locations

Simple photographic monitoring is a practical and cost-effective method of monitoring a restoration project. Photographic monitoring visually documents change in a site as restoration progresses. Photo monitoring of the NMC Amphibian Habitat Enhancement Project was conducted in August 2017, November 2017, June 2018, and May 2019. A photo monitoring map of the restoration area was generated by walking the perimeter with a geographic positioning system (GPS) unit and selecting sites from which the restoration work could be visually covered. Thirteen locations were chosen to use for photo point monitoring (Figure 13). At each point, photos were taken looking in a variety of directions to best capture restoration efforts. Photos from a subset of those points are presented in this report. Google earth imagery pre- and post- earth moving is also presented here to capture the trail system which was installed in October 2017. However, the most recent google earth imagery is from November 2018, so it does not show the most recent segment of trail which was installed during the summer of 2019.
